Repeated Damage Of Fulbari By-Pass Road: Causes & Measures For Restoration

Dr. Manas Kumar Mukherjee

Professor of Civil Engineering Jalpaiguri Government Engineering College West Bengal, India.

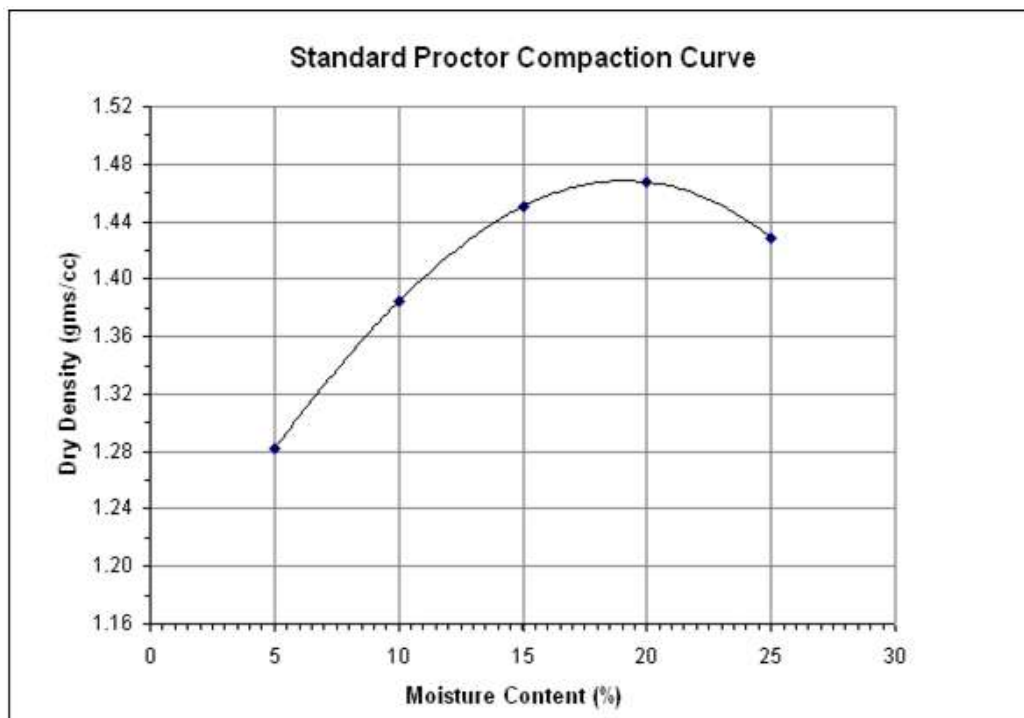
**A Sample of the Modified Proctor Test
B-H-1**

O.M.C = 19.00%
M.D.D = 1.47 gm/cc
