## **Improved Automobile Engine Shaft Thrust Pump Cessation Detection**

*Automobile thrust shaft bearing is the most vital module of water pump based on its fatigue cessational consequences that causes the abnormal operation of the system. Conversely, the cessational mechanisms of the bearing are still unclear. In this article, the cessational analysis on the engine thrust shaft bearing was carried out by using the measurement of material composition and properties, observation of macro and micro morphologies, and theoretical analysis of the cessation. The wear behavior and cessational mechanisms were elucidated, and the prevention measures were further proposed. The cessation was identified from the fracture of the bearing cage causing severe wear of the roller and the mandrel originated from the surface fatigue and the cessational attributes to the great radial deflection on load. Additionally, the decreased weight of the impeller and the shaft connector and the increased bearing thickness were recommended to improve the bearing operation.*

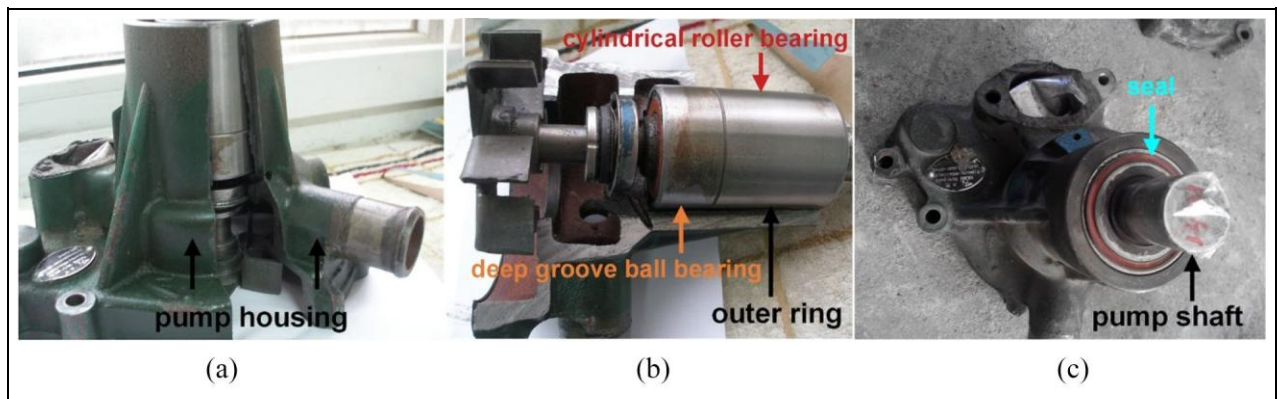
The damaged bearing installed on the water pump shaft of the automobile engine, after running mileage of about 600,000km, was dismantled for failure analysis. The bearing with type of WR2552185 has abnormal vibration and noise, and the materials are GCr15. The macroscopic morphology is shown in Figure 2. The outer ring of the two supporting bearings is made into a whole. Seals are used on both sides of the ring to form the composite parts of the bearing.

Figure 2. (a) Macroscopic Morphology of Pump Shaft Bearing, (b) Side View, and (c) Top View of Pump Shaft Bearing Without Pump Housing

The thrust shaft bearing of the pump was intact without obvious damage, and the bearing seal was unbroken, as shown in Figure 2. After disassembly, the overall bearing consisted of the deep groove ball bearing on the impeller side and the cylinder roller bearing on the power side as shown in Figure 3(a). To clarify the cessational mechanism of the pump bearing, the macroscopic morphologies of bearing groove, steel ball, and bearing retainer were examined separately. The core shaft groove surface and steel ball surface were bright without obvious running traces, as shown in Figure 3(b) and 3(c). In addition, there was no obvious damage on the cage as depicted in Figure 3(d). Note that the lubricant of deep groove ball bearings was dark brown and bright without no obvious discoloration. Therefore, it was concluded that the deep groove ball bearing on the impeller side operated normally.

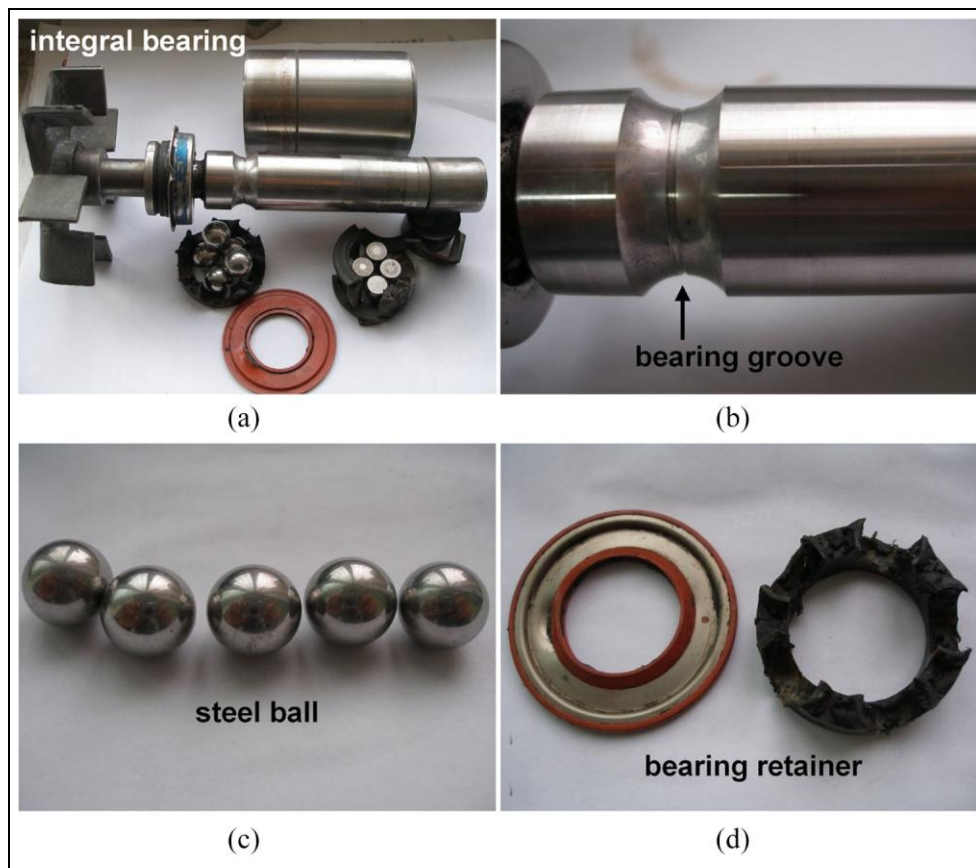
Figure 3. Disassembly Morphology of Pump Shaft Bearing: (a) Integral Bearing, (b) Groove of Deep Groove Ball Bearing, (c) Bearing

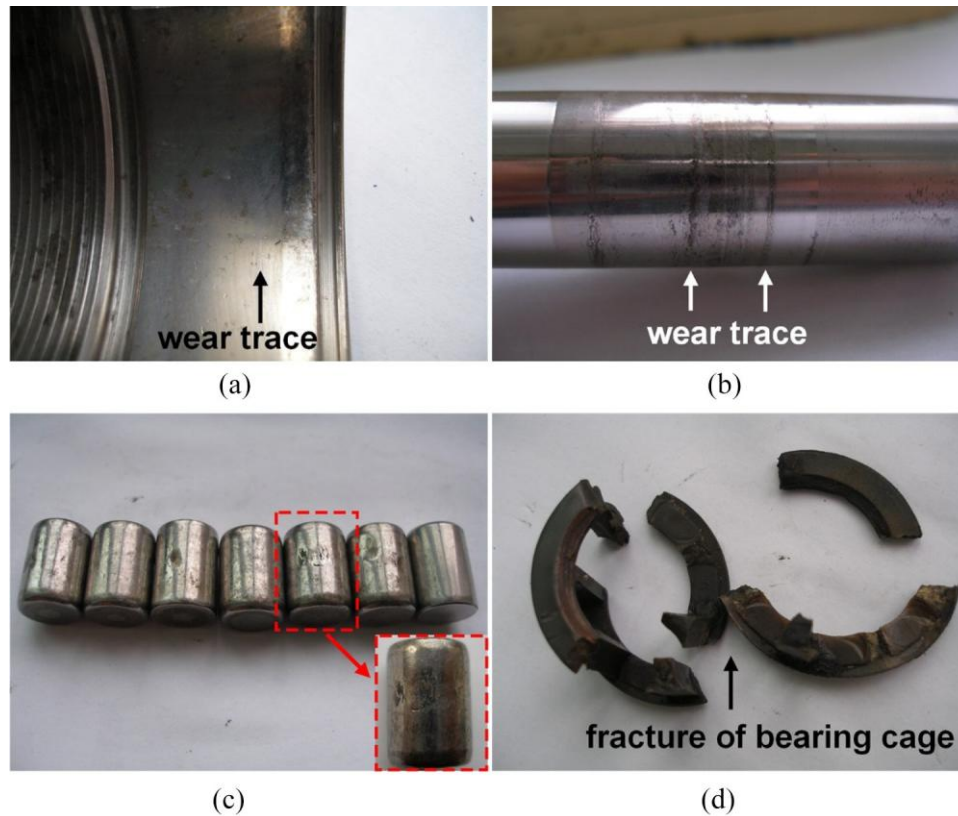
The components of the cylinder roller bearing including outer ring, cylindrical roller, and bearing cage were disassembled and examined respectively, as well as the mandrel surface. The raceway colour of outer ring was dark gray with local circumferential wear traces and pits, as shown in Figure 4(a). There were many circumferential wear traces on the surface of the raceway of mandrel, which were distributed along the circumference and accounted for about 2/3 of the whole circumference (Figure 4(b)). Among the seven rollers, surface colour was gray-black and there were evenly distributed pits and wear traces. At the same time, the end faces of cylindrical rollers were bright without obvious damage as shown in Figure 4(c). The cage was seriously damaged and unable to be completely spliced together, and there were more fractured parts on the both ends and less damage to the longitudinal girder, Figure 4(d). Therefore, it was inferred that the damage of bearing cage occurred first at the both ends. Consequently, the vibration and noise abnormalities of the water pump shaft bearing were mainly attributed to the failure of the cylinder roller bearing on the power side. Therefore, the following failure analysis mainly focused on the hardness distribution, crack propagation, and fatigue behavior of the cylindrical roller bearing.

Figure 4 presents uneven worn surface of the failed mandrel at two randomly selected locations. The wear characteristics, including furrow, peeling off, and micro-cracks, were mainly found on the worn surface. During the bearing operation, the friction and wear occurred on the contact surface. The wear produced debris and wear particles as depicted in Figure 9(c) and (f) with high hardness, which could not be discharged in time and remained on the contact surface. The abrasive dust rubbed repeatedly between the contact surfaces and played a role of ploughing, resulting in the generation of furrow, as shown in Figure 9(a) and (d). Due to the eccentric loading, the local stress at the surface increased. The high temperature generated as a result of the friction process led to the increased temperature of the contact surface and the formation of secondary quenching and tempering layers. Additionally, the abrasion resulted in the uneven surface and the stress concentration at the local contact points, which caused the surface peeling and micro-crack as shown in Figure 9(b) and (e). As the bearings continued to roll, the micro-cracks propagated and produced the peeling off. Consequently, it was concluded that the bearing had surface origin fatigue failure after rolling.

Figure 4. Disassembly Morphology of Cylindrical Roller Bearing: (a) Wear Trace on Outer Raceway Surface, (b) Wear Marks On Mandrel Surface, (c) Damage Morphology of Roller Surface, and (d) Fracture Morphology of Bearing Cage.

The radial load of pump shaft bearing mainly consisted of tension of driving belt and the weights of water pump impeller and shaft connector. Hence, the following recommendations and measures are proposed: reducing the weight of water pump impeller and shaft connector, increasing the bearing thickness to improve the radial bearing capacity. The bearing thickness represented the mandrel diameter. As the thickness increased, the mandrel diameter ( $R$ ) in Equation (1) increased, resulting in the decreased contact force. On the other hand, the increased mandrel diameter promoted the reduced the bending deformation of the mandrel and prevented the reduction of length.

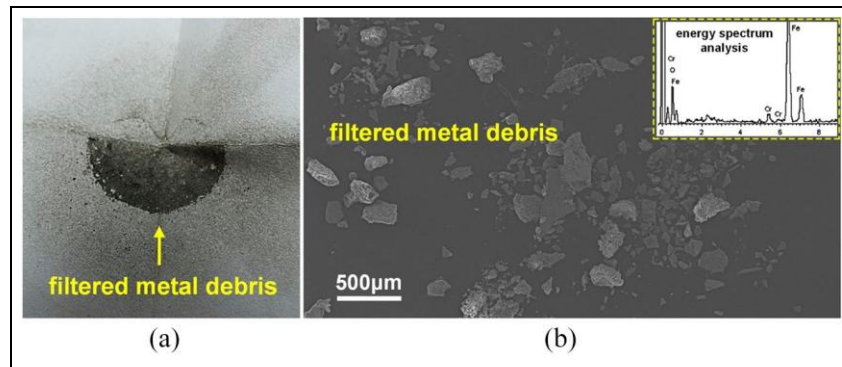
It was worth noting that the lubricating grease of cylindrical roller bearing parts was seriously oxidized and turned black. After cleaning and filtering with clean gasoline, only a small amount of metal debris was found to be free of foreign bodies as shown in Figure 5(a). Through the energy spectrum analysis, the main chemical elements were detected to be Fe, Cr, and O without other abnormal elements, as shown in Figure 5(b).

Figure 5. Morphology of Filtered Metal Debris (a) and SEM Images of the Debris and Corresponding Energy Spectrum Analysis (b).

The Morphology of the filtered metal debris are shown in Figure 5(a) and SEM images of the debris and corresponding energy spectrum analysis also shown in Figure (b) rubbed repeatedly between the contact surfaces and played a role of ploughing, resulting in the generation of furrow as shown in Figure 9(a) and (d). Due to the eccentric loading, the local stress at the surface increased. The high temperature generated due to the friction process led to the increased temperature of the contact surface and the formation of secondary quenching and tempering layers. Additionally, the abrasion resulted in the uneven surface and the stress concentration at the local contact points, which caused the surface peeling and micro-crack as depicted in Figures 9(b) and (e). As the bearings continued to roll, the micro-cracks propagated and produced the peeling off. Consequently, it was concluded that the bearing had surface origin fatigue failure after rolling.

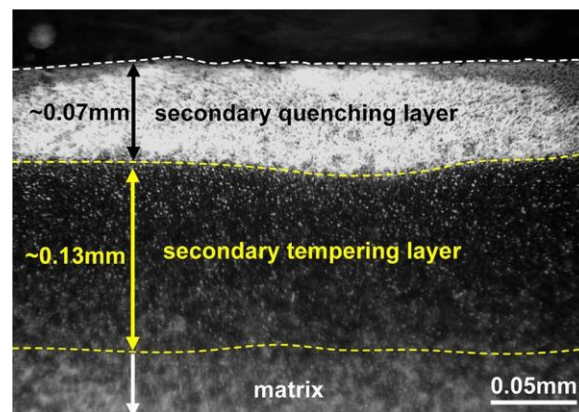
Figure 6. Surface Metallographic Structure of Worn Cylindrical Rolle

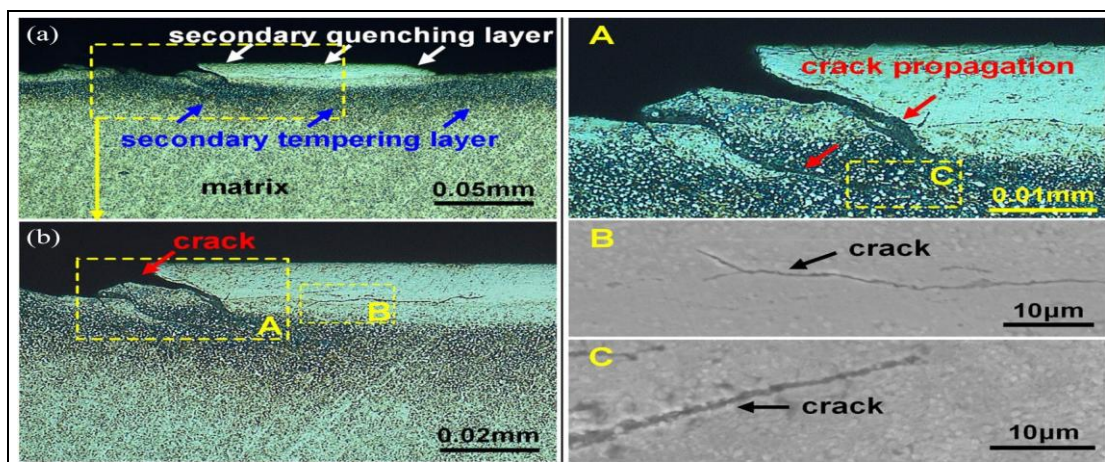
Figure 7. (a) Crack Morphology and (b) Corresponding Magnification in the Secondary Quenching and Tempering Layers of the Worn Mandrel. A, B, and C Represents the Local Magnification of the Dotted Yellow Regions

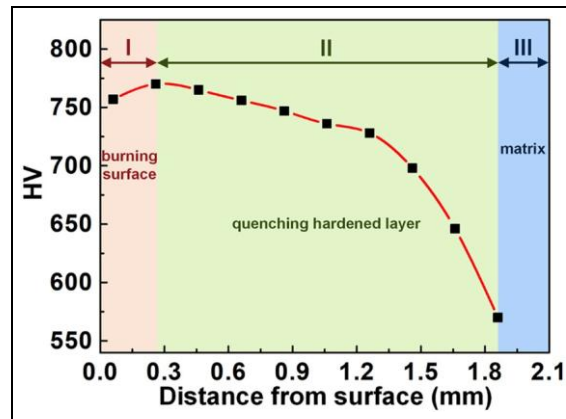
Figure 8. Gradient Curve of Micro Hardness Distribution of the Worn Mandrel.
