Detection of Gear Fault Using Vibration Analysis

Abstract: To achieve reliable and cost effective diagnosis, Motor current signature analysis is used to investigate the use of an induction motor as a transducer to indicate the faults in multistage gearbox via analyzing supply parameters such as phase current and instantaneous power. In gearboxes, load fluctuations on the gearbox and gear defects are two major sources of vibration. Further at times, measurement of vibration in the gearbox is not easy because of the inaccessibility in mounting the vibration transducers. This analysis system can be used for measuring the characteristics for a perfectly working gearbox and use the data as a standard for measuring faults and defects in other gearboxes. The objective of this paper is to design and diagnose fault in the gearbox using motor current analysis system at different gear operations on different loads. Steady load conditions on the gearbox are tested for current signatures during different gear operations. Also found the minimum power required to run on different gears and gear ratio. The motor current analysis system can be used further to specify mainly faults in the gear, mis

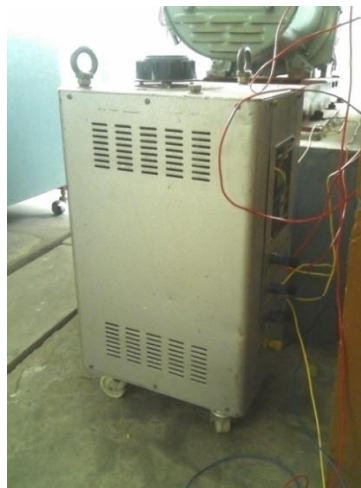
Fig 2: DIMMER STAT used in the experiment

The DIMMER STAT used in the experiment has the following configuration

Type : 15D-3P
Max KVA : 12.211

Output current 15amp per line

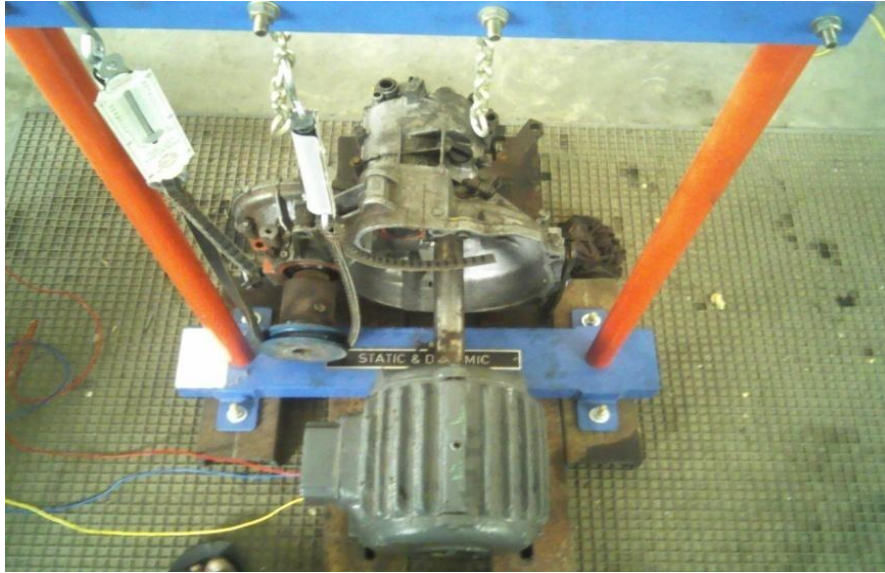
Fig 4: the Final fabricated set-up.

The setup was placed on a Cast iron rectangular block. Induction motor and gearbox were connected on the rectangular block. Channel was used for placing the 3-phase induction motor so that the motor and the gearbox are properly aligned with each other. Both the motor and gearbox are coupled by a shaft so that the gearbox is fixed completely and does not vibrate during high rotational speeds. Loading arrangement is done with a pulley connected to spring balances at gearbox output shaft.

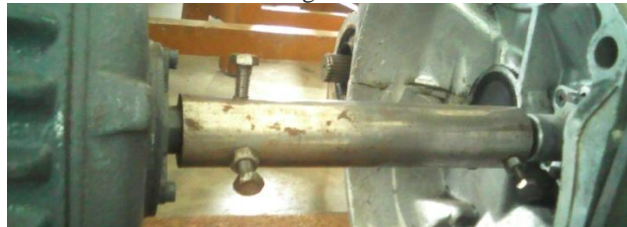
Fig.5: shaft coupled to motor and gearbox

Shaft coupling is a coupling used to connect two rotating shafts of different diameters. The shaft is connected to one end at the motor and the other end at gearbox.

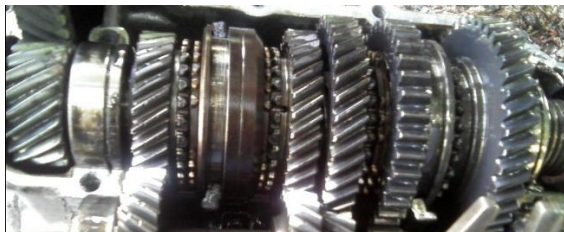
Fig.7: Gears before removing teeth.

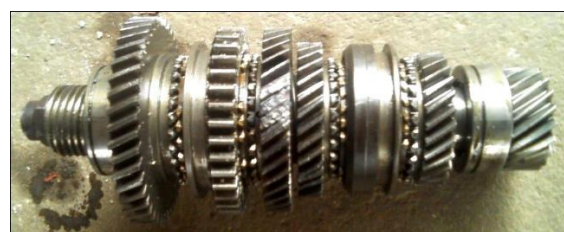
Fig.8: Gears after removing teeth.
