Microstructural Analysis of Corrosion of Welded Joints in Stainless Steel Used in Manufacture of Bioreactors

Abstract: Stainless steel is widely used in the manufacture of biogas power generation plants, it is a corrosion resistant material with good toughness, ductility and low cost if compared to titanium and nickel alloys. These materials are used in the form of welded tanks, pipelines and compression equipment. Analysis of those materials and the type of welding in the manufacturing plants affects thereof durability. There for it is necessary to check the structure of the welding, the occurrence of post-sensitization of the material information and the welding structural properties of the material before and after the process. The objective of this study is to assess the effect of welding on the microstructure and structural steel property of AISI 304 and AISI 316. These stainless steels of austenitic class were welded by autogenous TIG and MIG with additional material. The welded materials were also exposed to a solution of ferric chloride 3 ($FeCl_3$). This solution was responsible for the attack of the material welded, being made as specified in ASTM 48G. Finally inspection

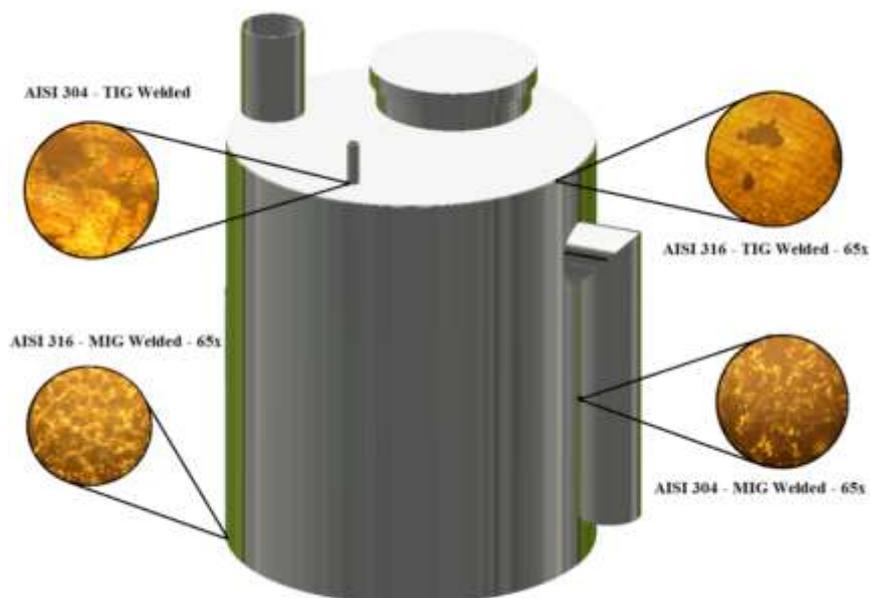
All research related to energy efficiency technologies and the uses of renewable energy are important factors for sustainable energy [1]. The production of biogas occurs in sealed tanks, called bioreactors, with non-oxygen atmosphere, which is why they are called anaerobic. Those tanks promote their generation by means of anaerobic bacterial digestion of the waste. They also have the role of reducing the rate of environmental contamination by confinement of the resulting gas, which no longer vented to atmosphere and treating the organic substrate material allowing further use of the natural cycle as biofertilizer [2]. Figure 1 shows a bioreactor built in stainless steel AISI 316L for this research.

Figure1. Bioreactor –Stainless steel austenitic AISI316L.

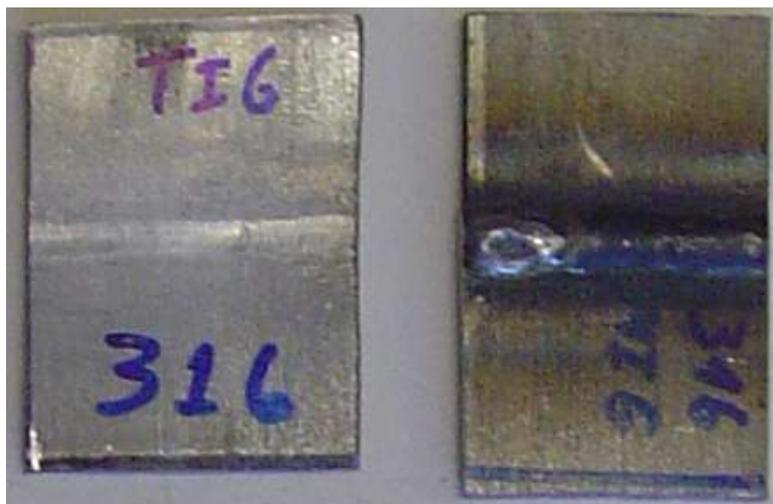
In the experiments we used the TIG welding process, autogenously, without adding material or MIG, where the welding are made with wire ER 308 L AS, for the ASTM 304 and ER 316 AS, to the 316. The shielding gas used was argon, and has been taken into consideration welding parameters and material thickness. The specimens were welded and a sample was obtained of each material. A top view of the welding can be seen in Figure 2 and 3.

Figure 2. Aspects of the weld in TIG and MIG steels AISI 316.

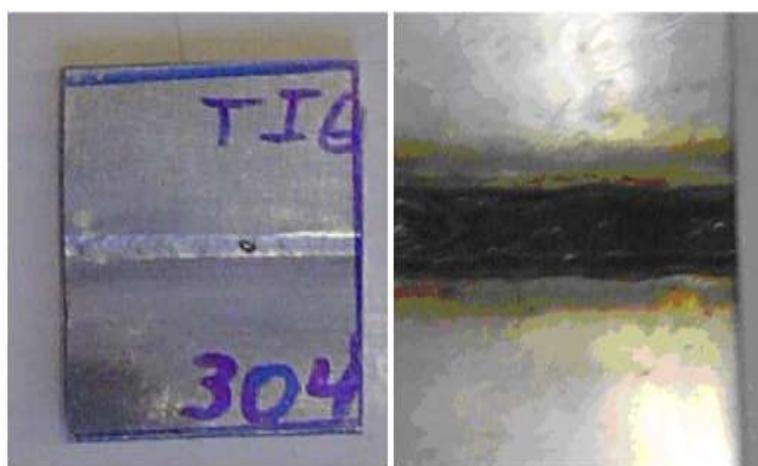
Figure 3. Aspects of the weld in TIG and MIG steels AISI 304.

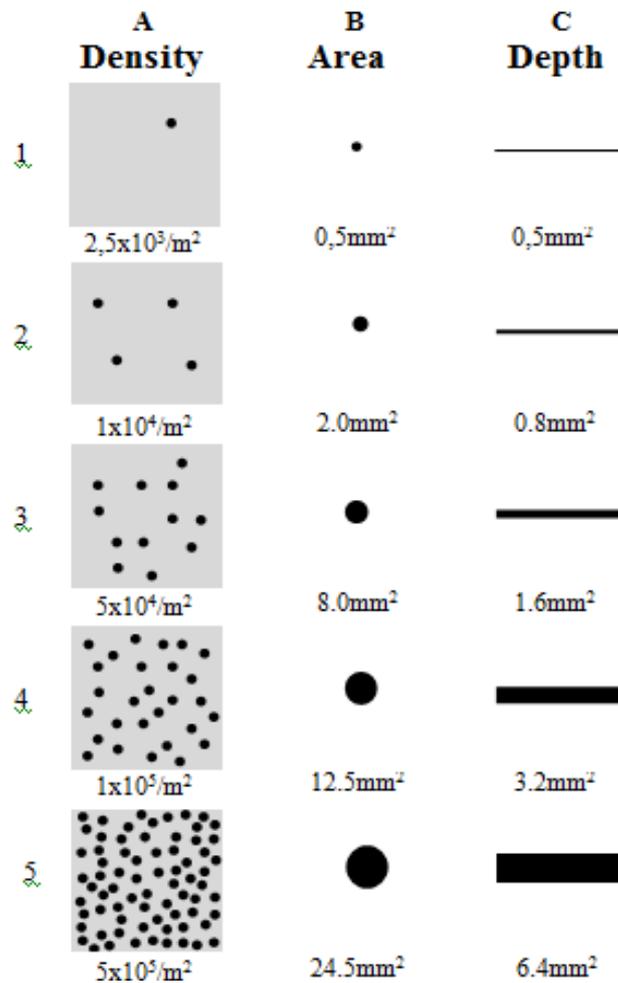
G46. The pitting density is a factor of great importance, since with this data we can assess the depth of pits, according Figure 4 is part of ASTM G46.

Figure 4. Density ratio, area and depth of pitting.

The density of pitting was evaluated based on the standard of ASTM G46 shown in Figure 3, this parameter is used to evaluate the depth of drilling. The results are shown in Table 7.

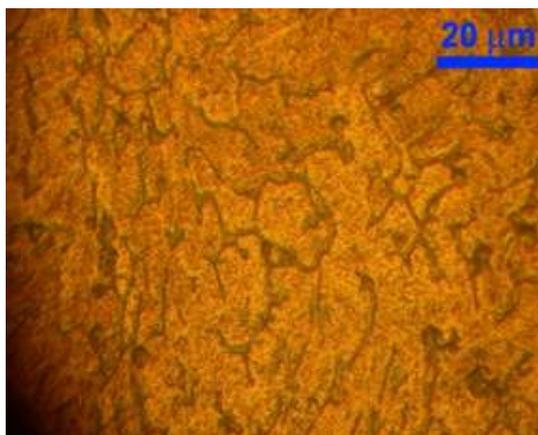
The metallographic wire welded and heat-affected zone in the steel AISI 316, are shown in Figure 5, 6, 7 and 8 respectively.

Figure 5. Sample(316)weldedprocess (TIG) autogenouscross sectionthroughthe bead (1000X).

The middle of the bead, both for the MIG, TIG process as in, compositions are consist of delta ferrite structure from the melting of the material (Fig. 7). The ZAC weld for both processes continued austenitic, but with different structural, which reduced its resistance to chemical attack used to perform the metallography. The welded metalografhicbead and heat affected zone for the AISI 304 steel are presented in Figures 9, 10, 11 and 12.

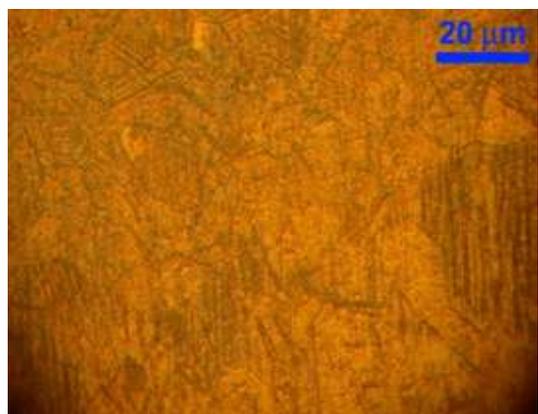
Figure 6. Sample(316)weldedprocess (TIG) ZACautogenouscross section(1000X).

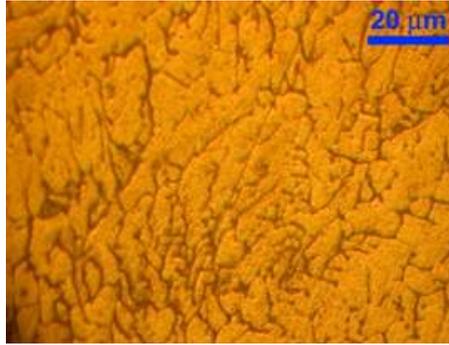
Figure 7. Sample(316)weldedprocess (MIG) cross sectionthrough thebead (1000X).

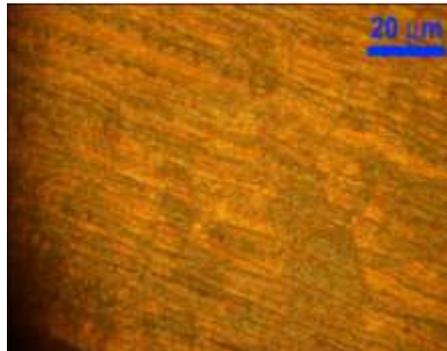
Figure 8. Sample(316)weldedprocess (MIG) cross sectionthrough thebead (1000X).

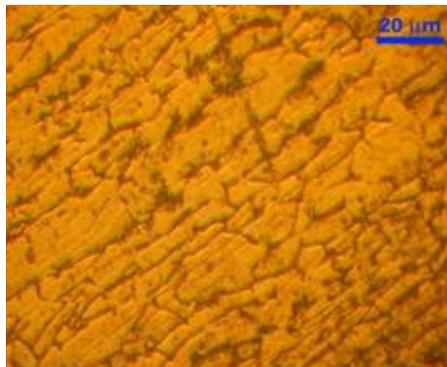
Figure 9. Sample (304) welded process (TIG) autogenous cross section through the bead (1000X).

The metallographic images in middle of the bead for the welding process TIG and MIG were presented by the Figures (9 and 11) revealing a structure comprised of delta ferrite in the ZAC welds is carried out by TIG welding can check a recrystallization from the heating during welding as shown in figure (10). In the ZAC process for the MIG welding is possible to verify the structural changes that this region weakened when exposed to metallographic etching reagent.

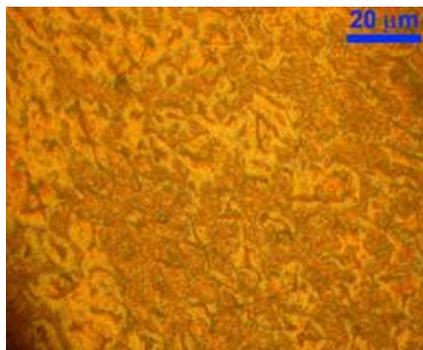
Figure 10. Sample (304) welded process (TIG) ZAC autogenous cross section (1000X).

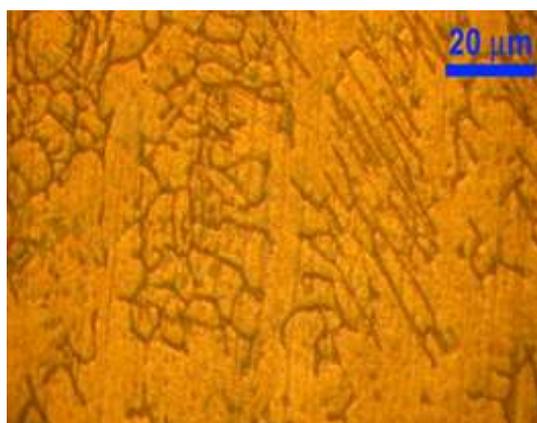
Figure 11. Sample (304) welded process (MIG) cross section through the bead (1000X).

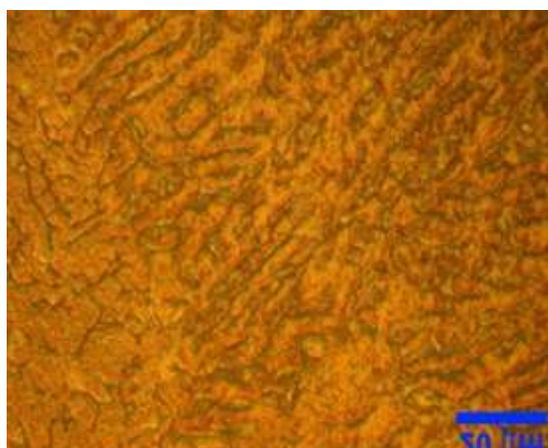
Figure 12. Sample (304) welded process (MIG) cross section ZAC (1000X).

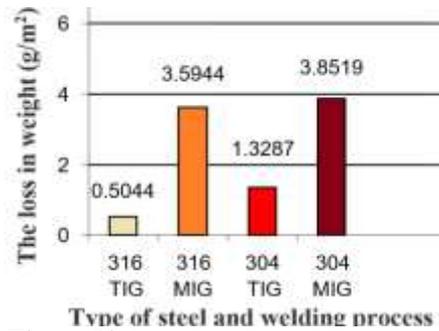
All samples were immersed in a solution of FeCl_3 (ASTM G48A), the condition of maximum mass loss for validation of the test is 4 g/m^2 , the materials were weighed on an analytical balance to four decimal places, the mass loss is analyzed in Table 4 and in the graph of Figure 13.

Figure 13. Mass loss for stainless steel.

From the analysis of the chart (Fig.13) it can be concluded that for the AISI 316 and AISI 304, the weight loss was less than 4 g/m² which validates the test method. Austenitic stainless steel AISI 316, showed a weight loss of 0.5044 g for TIG (autogenous) and 3.5944 g which indicated a significant difference in weight loss, demonstrating the superiority of the process applied to autogenous TIG welding of AISI 316 steel in view of corrosion resistance.

Similarly it was observed a wide variation in weight loss for the AISI 304 compared the process of TIG and MIG welding, and the mass loss to the TIG welding process was 1.3287g, process for the MIG was of 3.8519g. It is clear superiority of the TIG process for the autogenous welding of the AISI 304 steel in view of corrosion resistance of the material.

Also can be verifying the superiority of AISI 316 stainless steel welded by the TIG process on AISI 304 welded by the same process. For the mass loss was 0.5044 g for the steel AISI 316 and 1.3287 g for the AISI 304 stainless steel welded by the same process. For the MIG process was observed superiority of the steel AISI 316 with respect to the steel AISI 304, because the mass losses were 3.5944 and 3.8519 g respectively.

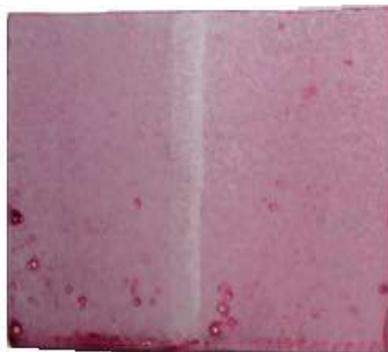
The specimen in Figure 14 is the material AISI 316 TIG welded by autogenous material and the figure 15 is the steel AISI 316 welded by MIG process, after testing in liquid penetrant can estimate the density of pitting. The density of pitting is estimated in view of the standards ASTM G 46. In order to compare the TIG welding process and MIG welding process, is possible to demonstrate the superiority of the TIG process for the AISI 304 steel in terms of density test according to pitting can be seen in Figures 14 and 15.

Figure 14. Test of the steel penetrating liquid AISI 316 TIG welded.

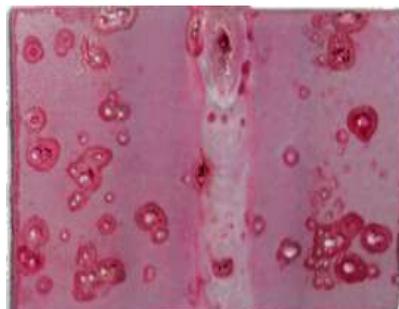
Figure 15. Test of the steel penetrating liquid AISI 316 MIG welded.

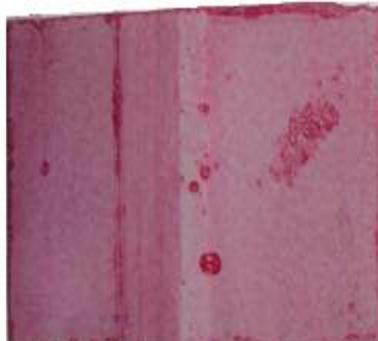
The samples of AISI 316 in Figure 16 and the Figure 17 were welded by autogenous TIG and MIG, respectively. After testing in penetrating liquid can be estimated the density of pitting in view of ASTM G46 standards. Comparing the processes of autogenous TIG welding and MIG in the same type of steel was possible to demonstrate the superiority of the TIG process for steel quoted in terms of density of pitting.

Figure 16. Test of the steel penetrating liquid AISI 304 (MIG).

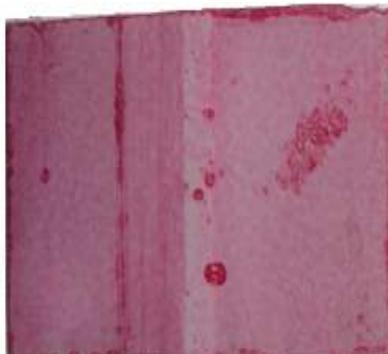
Figure 17. Test of the steel penetrating liquid AISI 304 (TIG).

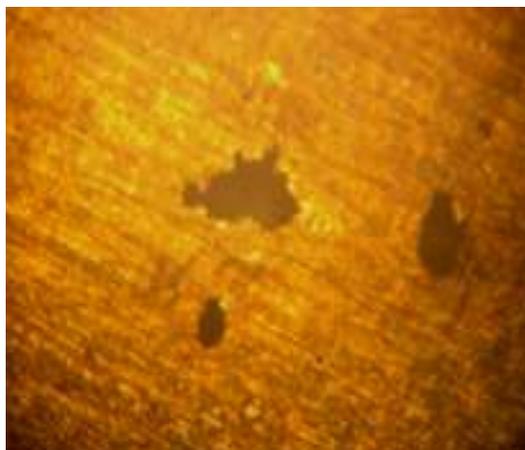
The images shown below indicate the formation of pits on the surface of AISI welded by TIG welding as shown in Figure 18.

Figure 18. Picture of the formation of pitting of stainless steel AISI 316 (65x) welded by the process TIG.

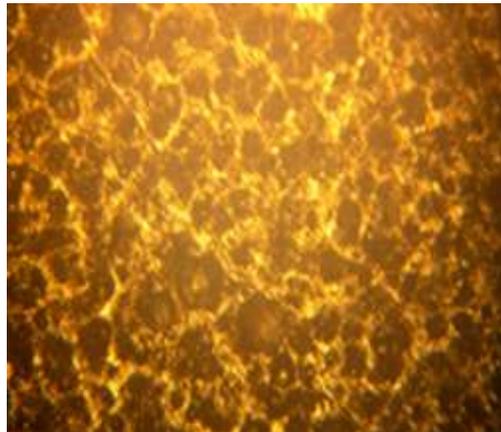
Formation of pitting in AISI 316 welded by MIG process as shown in Figure 19.

Figure 19. Image formation of pitting in stainless steel AISI 316 (65x) MIG welded.

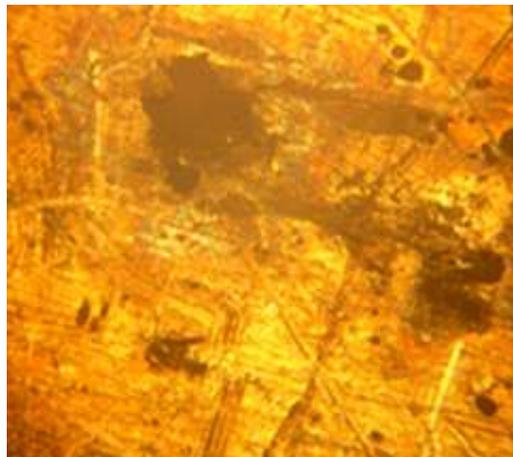
In Figure 20 we can see the formation of pitting in AISI 304 welded by the TIG process.

Figure 20. Formation of pitting in AISI 304 welded by the TIG process (65x).

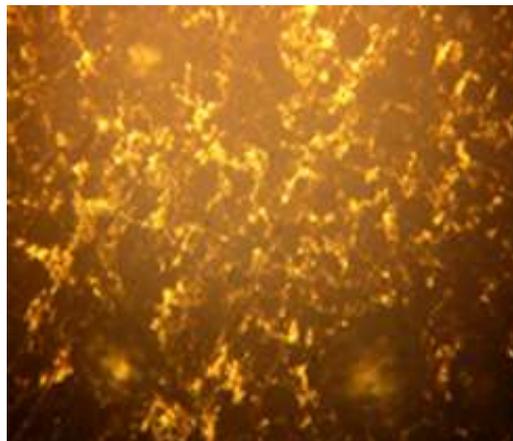
In Figure 21 we can see the formation of pitting in AISI 304 welded by MIG process.

Figure 21. Formation of pitting in the weld bead of AISI 304 (65x).
