# Detecting and Imaging Historical Graves by Using Visual Inspection and Ground Penetrating Radar Investigation

**Abstract:** This is a comprehensive summary of the geotechnical investigation of the Historical Pulaski County Poor Farm Cemetery, southeast Waynesville, Missouri. The study demonstrates that unmarked graves in an abandoned historical cemetery can be located using visual site inspection and ground penetrating radar techniques. During the course of these investigations, multiple visual site inspections of Pulaski County Poor Farm Cemetery were conducted and ground penetrating radar data were acquired. Based on the visual site inspections and the interpretation of ground penetrating radar data, a total of one-hundred and fifty-one (151) graves were identified; eighty-seven (87) of the graves were mapped using visual site inspection techniques; sixty-four (64) were identified based on the analysis of the ground penetrating radar data. A report was submitted to the Pulaski County Historical Society, recommending that markers (wooden crosses) be placed on each identified grave. The visual site inspections and ground penetrating radar investigation were successful and proved

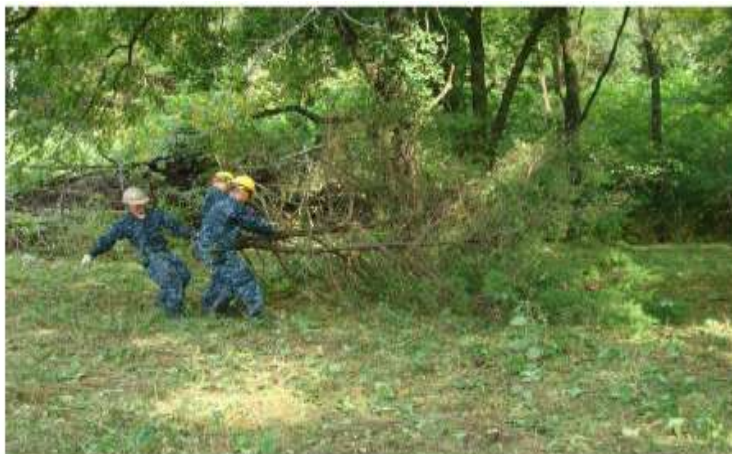
**Figure 3:** United States Navy Seabees Clearing the Site

On August 14, 2010, about one month prior the first Missouri S&T crew visit, a group of volunteers from United States Navy Seabees cleared vegetation from the Pulaski County Poor Farm Cemetery site in support of restoration efforts headed by the Pulaski County Historical Society. Figure 3 is photograph of United States Navy Seabees clearing trees and vegetation from the cemetery site. After the Navy group completed their work, the site was suitable for visual site inspection and ground penetrating radar investigations with the objective of detecting and mapping old historical graves within the Pulaski County Poor Farm Cemetery site.

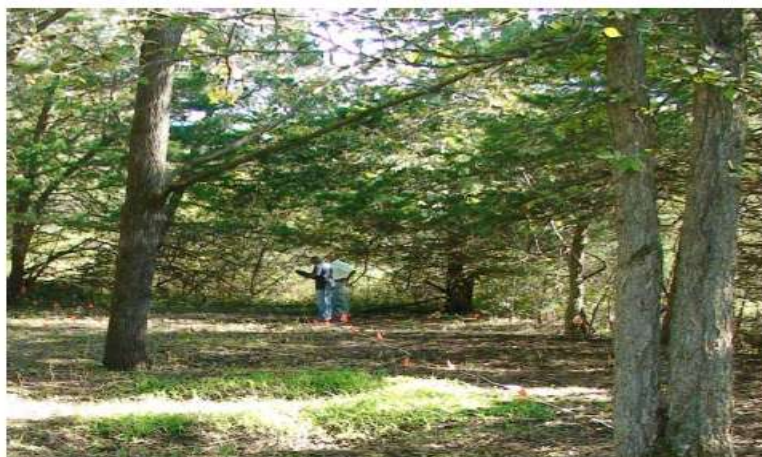
**Figure 4:** Uneven Ground, Trees, Tree Roots and Branches

The photograph in Figure 4 illustrates conditions when the Missouri S&T crew first visited the site. The Pulaski County Poor Farm Cemetery had mostly been cleared of trees and brush prior to our arrival on the first day of the GPR survey (September 12, 2010), but many obstacles such as trees, shallow roots, rocks, and sunken ground remained, making it difficult to perform a proper GPR survey. As part of the initial visual site assessment, a base map was made of all the obstacles (trees, tree roots, sunken ground) that could adversely affect GPR data acquisition (Figure 6).

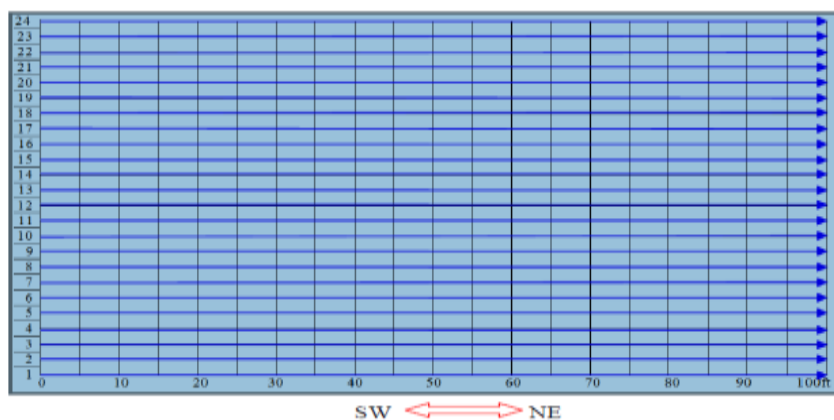
**Figure 5:** Map [1/2] of GPR Traverses (1-24)

**2.1.1.4 GPR Traverses.** The author used a measuring tape and laid out 48 traverses on the Pulaski County Poor Farm Cemetery site (Figure 5 shows example of 24 traverses). Starting from southwest corner of the site to the northeast, the length of each traverse is about 100ft, depending on accessibility. The interval spacing between each adjacent traverse was 2ft apart. Figures 5 shows the 24/48 GPR traverses which were laid out across the Pulaski County Poor Farm Cemetery site, these traverses run from Southwest to Northeast with 2ft intervals between adjacent traverses. Collectively these traverses cover the entire Pulaski County Poor Farm Cemetery. Starting from station “0”, the author walked along each traverse and mapped all indentations (depressions; sunken ground), trees, tree roots, headstones, etc., Figure 6.

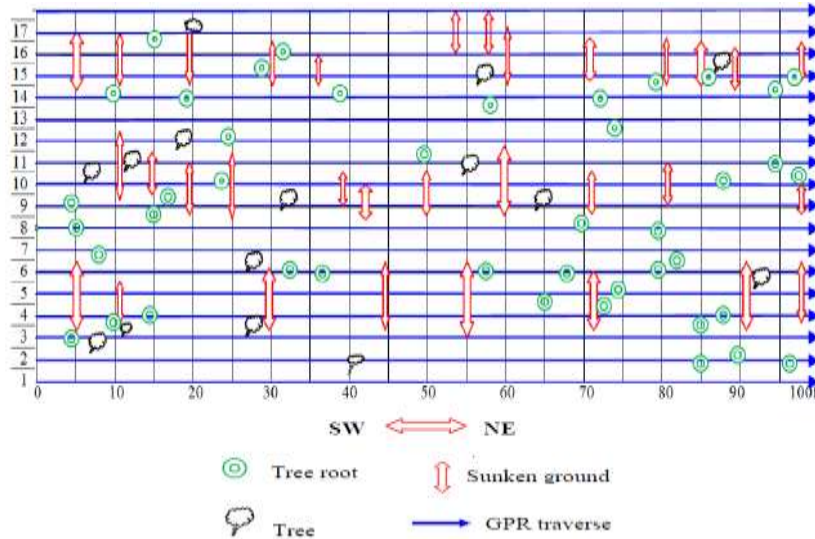
**Figure 6:** Base Maps [1/3] of Pulaski County Poor Farm Cemetery

**2.1.1.6 The Base Map.** After all the sunken ground, trees and tree roots on the Pulaski County Poor Farm Cemetery site were mapped, a final base map was created to show all these natural features on the site. The trees and tree roots were mapped, because the author did not want to misinterpret the GPR signatures of tree roots as graves. Figures 5 shows one example of the base map of the Pulaski County Poor Farm Cemetery site. One of the good result of visual inspection is creation of the base map that shown the location of the trees, tree roots and sunken ground (Figure 6). The depressions (sunken ground) are oriented almost east to west.

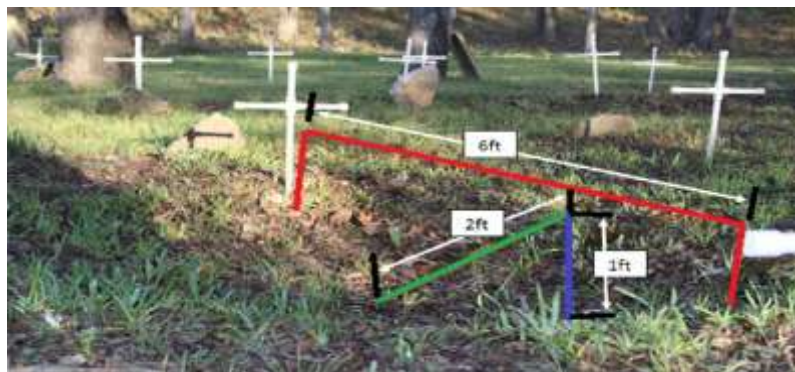
**Figure 7:** Typical Depression on the Site

**2.1.1.5 The Significance and Nature of the “Sunken” Ground (Subsidence above Graves).** The expression “sunken ground”, as used herein, refers to the visible depressions that are observed at many locations within the confines of the cemetery. These depressions were almost certainly caused by the degradation of the wooden coffins and human remains, and the collapse of the overlying soil. On the Pulaski County Poor Farm Cemetery site the depression of the sunken ground varies typically between 0.5ft and 1ft in depth. The centers of many of the depressions are about five feet apart indicating most the graves were spaced at about five-foot intervals. In many of the sunken grave sites, small trees have taken root. Typically, the depressions are about 6ft in length and 2ft in width (consistent with burial practices as described by the Pulaski County Historical Society). Figures 7, 8 and 9 show three examples of depressions (subsidence above graves) on the Pulaski County Poor Farm Cemetery site. Figure 6 shows that the length of depression is about 6ft, the width is about 2ft and depth is about 1ft. The volume of this depression is approximately 12ft<sup>3</sup>.

All of the visually identifiable depressions (sunken ground) on the Pulaski County Poor Farm Cemetery site were mapped. Each indentation is presumed to correspond to a grave. The sunken ground is believed to be caused by the deterioration of the bodies and the coffins. The depressions are oriented almost east to west (Figures 7, and 8).

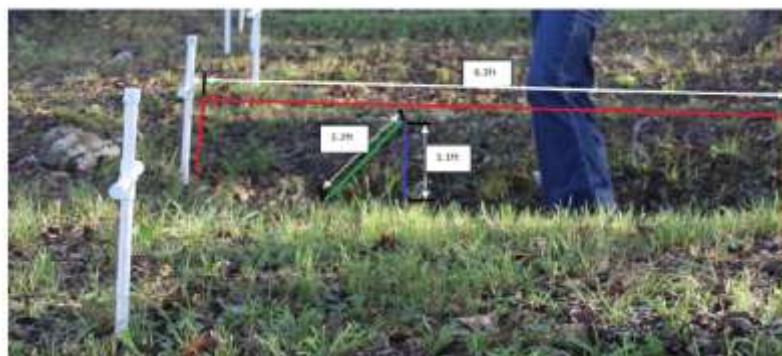
**Figure 8:** Typical Depression on the Site

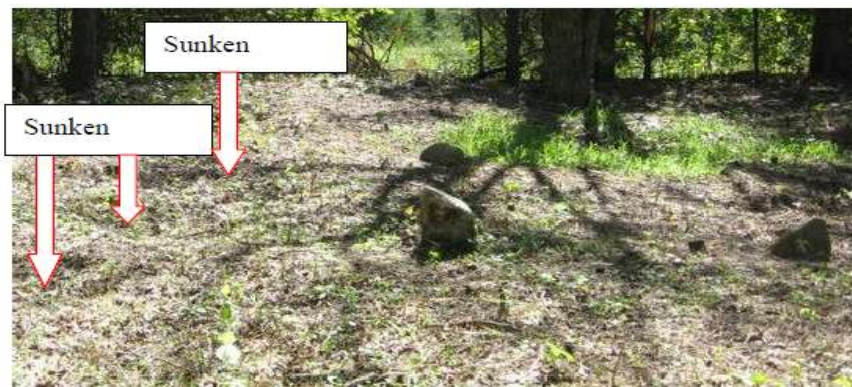
**Figure 9:** Rocks and Sunken Ground

In above photo, a few rocks can be seen. These may have been used as grave markers at one time. Also, sunken ground is imaged on the photograph.

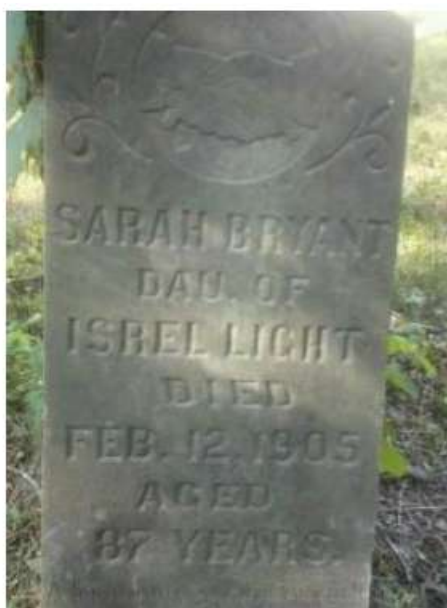
**Figure 10:** Still-Standing Headstone

On the Pulaski County Poor Farm Cemetery many of the graves are difficult to identify, either because they were never marked, or because the grave markers have decayed, been removed, or been destroyed. Some graves were definitely marked headstones, as a few were found randomly dispersed on the site. Figures 10 and 11 show the only still-stand headstone marker and a non-standing headstone marker, respectively.

When the S&T crew walked across the Pulaski County Poor Farm Cemetery site looking for clues about the locations of unmarked graves, it did find two old headstones. One was dated 2/12/1905 (Figure 10); and other one was dated 6/5/1871 (Figure 11). This indicates that the Pulaski County Poor Farm Cemetery is at least 139 years old. One of significant result is measuring the length, width, and depth of the sunken grave and the result shown consistent with buried practice of other cemeteries in other places in Missouri, (Figures 7, and 8).

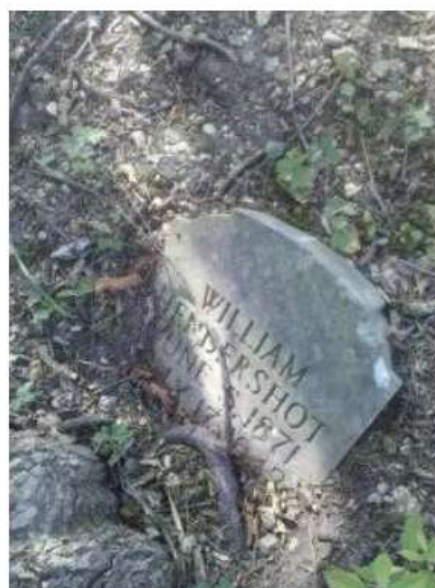
**Figure 11:** Non-Standing Headstone Dated Dated 2/12/1905 Dated 6/5/1871

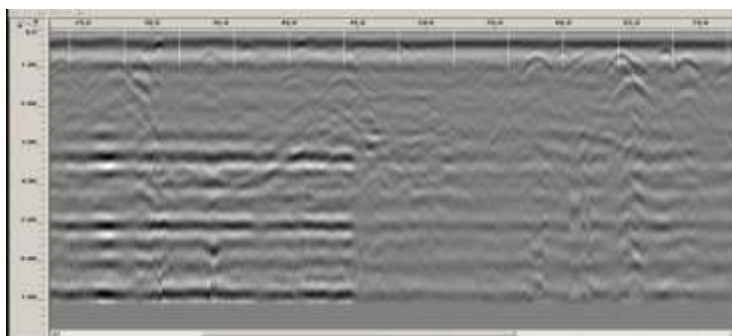
**Figure 12:** Shows Ground Penetrating Radar 2D Data Acquisition Across the Pulaski County Poor Farm Cemetery.

Ground penetrating radar (GPR) data were acquired on the Pulaski County Poor Farm Cemetery using a 400 MHz antenna. The locations of the traverses along which ground penetrating radar data were acquired are shown as Figure 12. The ground penetrating radar profiles were collected along traverses spaced at 2ft intervals beginning in the southwest corner of the study area running to the northeast corner of the Pulaski County Poor Farm Cemetery site. The ground penetrating radar data were collected in the parallel or unidirectional mode with the operator returning to the same zero (0) ft. mark to start the next traverse profile. The ground penetrating radar data were collected from Southwest to Northeast. A total of 48 ground penetrating radar profiles were collected across the Pulaski County Poor Farm cemetery. Measuring tape was used to measure all 48 ground penetrating radar traverses. The tape was stretched from zero (0) ft. mark to 100 ft.

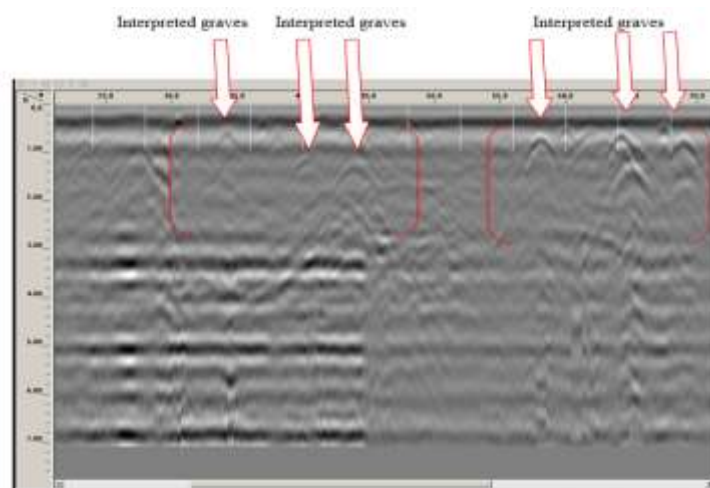
Figure 13 Shows Ground Penetrating Radar 2D Data Processed Across Pulaski County Poor Farm Cemetery, with Clear Locations of the Interpreted Graves. [2D traverse # 10]

According to the manufacturer of the Missouri S&T GPR system (GSSI SIR-3000 User's Manual, 2007), the Radan software was created to fill a GPR data processing need, and to provide both novice and experienced GPR users with processing capabilities using a windows XP Pro or Vista format, making the processing radar images easy. The Radan software package consists of a main module and add-on modules. The main Radan module (henceforth called Radan) provides all of the tools necessary to display, process, analyze, interpret and present ground penetrating radar data for most applications. (Geophysical Survey System, Incorporated, 1995, RADAN for Windows Manual), (Annan, A., and Cosway, S., 1994). Total of 48 GPR data were processed using Radan software. The quality of GPR data was excellent. Figure 13 shows one example of GPR data profile processed by Radan using 400 MHz antenna. You can clear see the GPR image shows well-defined reflection/diffraction hyperbola from the top of the coffins appears to be at a depth 1ft to 2ft.

**3.1 2D GPR Profile #10.** The 2D GPR profile #10, which acquired across traverse # 10, shows six (6) anomalies. The presence of those hyperbolic anomalies as the results of the reflected EM pulses from the top of the coffins. This six graves are located at 35ft, 40ft, 45ft, 57ft., 64ft., and 69ft mark of profile #10. Hyperbolic reflections in GPR traverses are originated from localized sources and can correspond to archaeological targets (Daniels, 1996; Conyers, 2004). The shape, depth and the length of those a hyperbolic reflector are vary and this may be as the results of the collapse of the coffins or due to deterioration of the bodies. There is no direct evidence of multiple and/or overlapping graves in this GPR profile. On traverse #10, the depth to the top of the most coffins about 1ft (Figure 13).

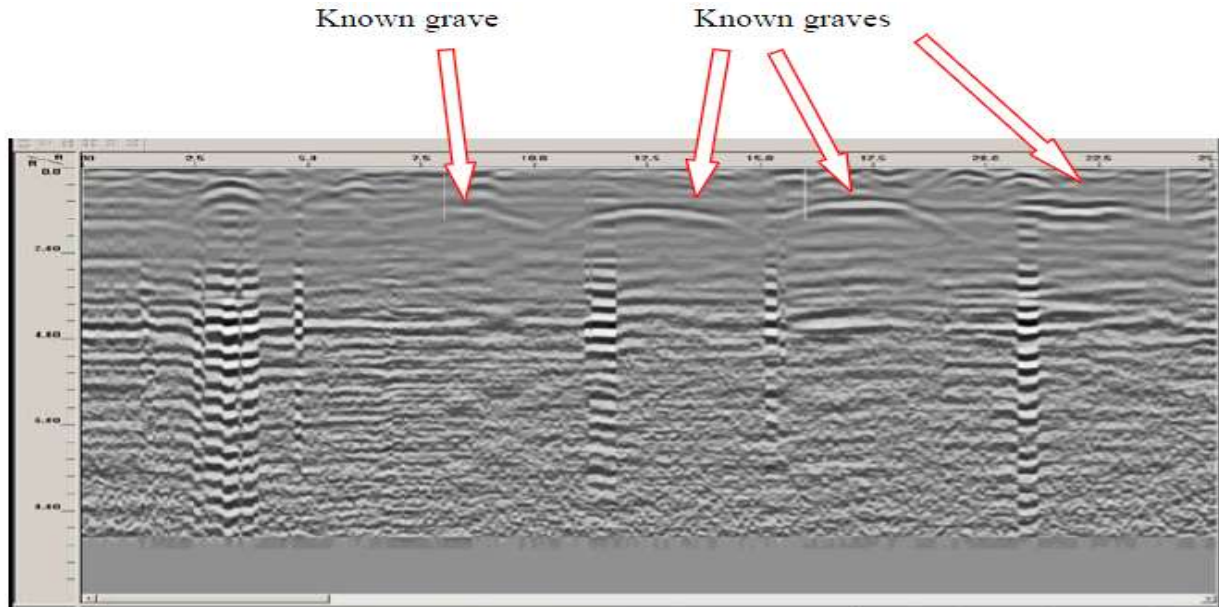
Figure 14: Ground Penetrating Radar (GPR) 2D Data Acquired Across Veterans Cemetery in St James, Missouri.

GPR image collected at the Veterans Cemetery in St. James, Missouri is shown on Figure 14. This site is more nearly ideal for GPR data collection since fewer limiting factors exist at this site. The data is included here for comparison purposes and also collected using a 400 MHz antenna. On Figure 14, the GPR image shows well-defined reflection/diffraction hyperbola from the top of the coffins appears to be at a depth between 1ft and 2ft. The spacing between these coffins is about 5ft, consistent with the burial practices at the Pulaski County Poor Farm Cemetery.

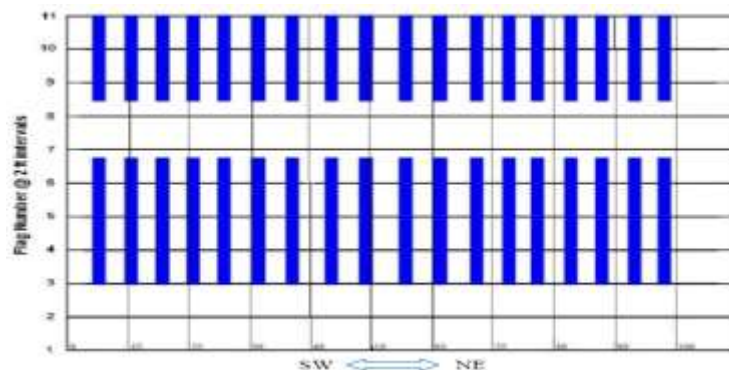
Figure 15: Maps [1/5] Approximate Locations of Interpreted Graves (Blue Areas)

**3.2 Location of the Graves.** Based on the a comprehensive visual inspection of the site, based on the interpretation of the ground penetrating radar data and based on the pattern of identifying graves on the site generated a map showing what believed the locations of all graves on the site. Understanding this interpretation it consistent with everything we could do with the site. Accordingly there are 151 graves were found on the (Figure 15 one example of five maps have total of 87 graves).
