Geo Environmental Study to Assess the Hazard of the Surface and Subsurface in Selected Construction Sites by Application of Combined techniques in (Kinta Valley) Perak, Peninsular Malaysia

ABSTRACT:

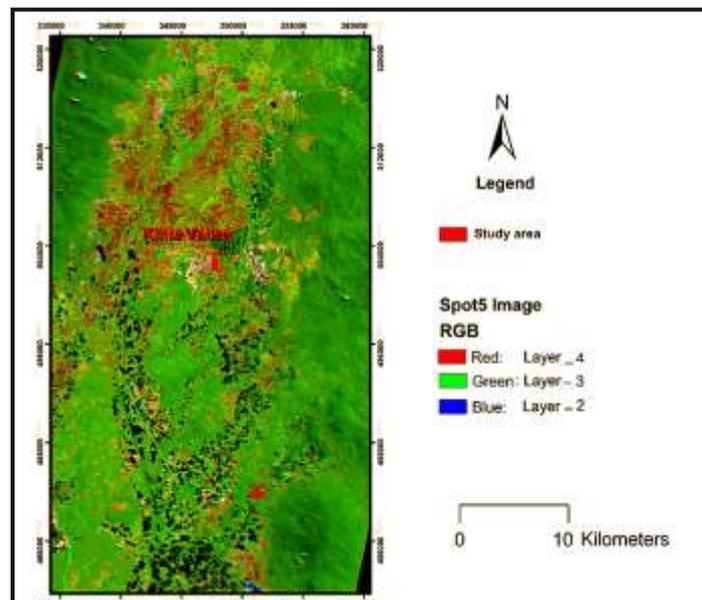
Figure 6: Five layers spot images of Perak state (2010) presenting the location of construction site #1, site #2 and site #3 north and south of Ipoh city (Kinta valley).

In this current work, usage of satellite images (five layers spot image of Perak state) is on the scale 1/5000 of year (2010), figure6. Additionally, Global Position System (GPS) and Geographic Information System (GIS) technologies have massively improved the investigations. The remote sensing provides updated information on land by using these methods instead of the common methods of mapping land and utilizing changes are typically high in cost and low in accuracy. Natural events and human activity features can observe by using current photograph and archived clearly identified data. The key limitation of aerial photographs and satellite images is that, depending on the scale and explanation of the images, it may not be feasible to pinpoint small or shallow sinkholes.

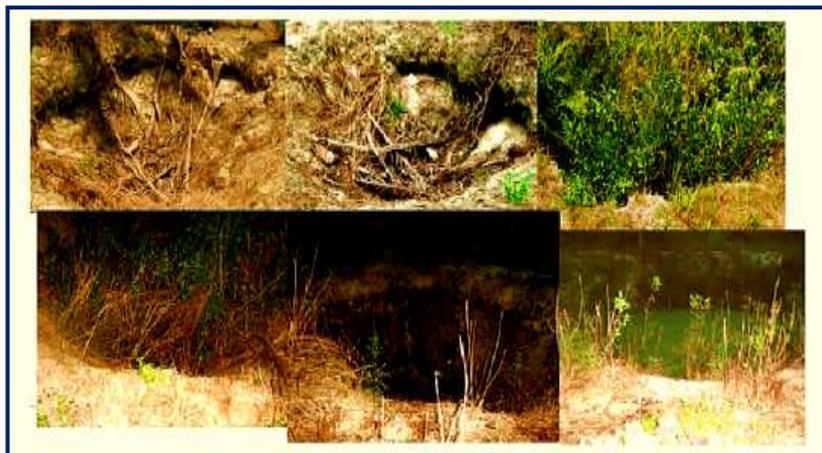
Figure 7 :Land Photographs viewing a number of sinkholes that identified as water in-fill, empty and covered with vegetation was determined as small and narrow in construction site#1, #2 and site#3

During the ground inspection at site #3, it showed that this region was part from the Ex-mining area. A group of different size of pools separating on surface formed due to effect of heavy rain were recognized in this site and describe as small to medium size with~ 1.5 m - ~15.0 m in diameters. Also found a number of cover soil collapse sinkholes with a depth about few meters and with a diameter from ~1m to less than ~5m, some pack with vegetation and others with sand or water infill. Only one subsidence sinkhole determines in the south east of this site is filled with vegetation's with ~50.0 m in diameter. A number of sinkholes that identified as water in-fill, empty and covered with vegetation was determined as small and narrow in construction site#1, #2 and site#3viewing in Figure 7.

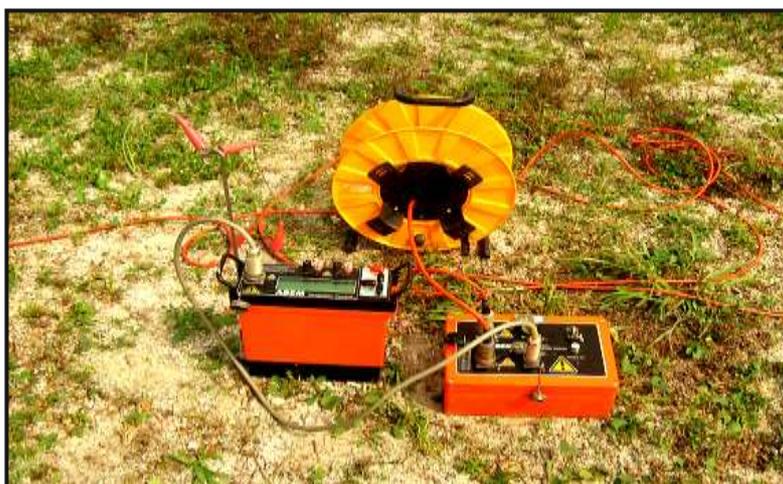
Figure 8: viewing the instrument type SAS1000 applied in geophysical survey

In a distinctive survey, most of the fieldwork involves laying out the cables and electrodes. After doing that, the measurements are taken automatically and stocked into the computer. This resistivity procedure usually gives a better grouping of spatial resolution and depth of study in karst terrain than any other geophysical technique. Figure 8 viewing the instrument used in this survey.

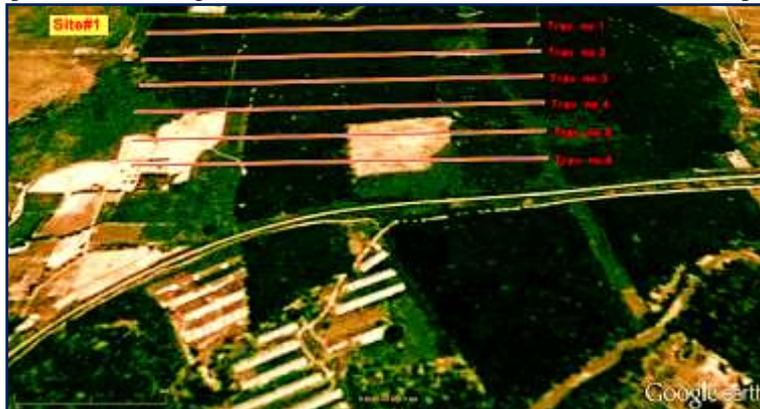
Figure 9: Satellite Image viewing the location of resistivity traverses in site #1 (north Taman Bandar Baru Putra)

profiles, using an 81-channel array in Winner configuration. The measurement length of each profile was 400 m, with an electrode spacing of 5m, on average, spaced at 25 m intervals between each profile. The total length of total traverses at this site was 2400 m, covering an area of 80000 m², with 340 data points composed for each (81-electrode) in one profile. On average, about 2040 data were collected from a total six profiles at this site.

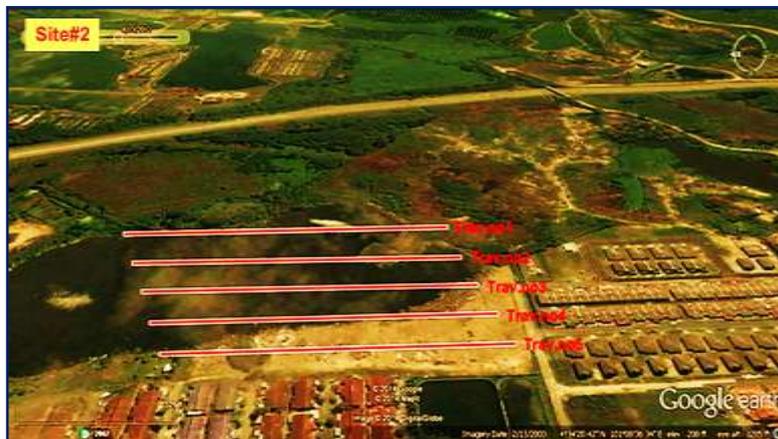
Figure 10: Google satellite image map (2002) viewing the locations of resistivity traverses which controlled in construction site #2 (Gunung Rapat –Taman Gunung View)

Electrical resistivity tomography (ERT) were applied in five (5) electrical resistivity traverses, traverse no.1 to Traverse #5 were controlled over and along the survey area in construction site #2 located in Gunung Rapat region, Taman Gunung View. These traverses oriented in the direction of (NW10°SE) in this construction site. The length of each profile is 200 m, with space interval of 25m between each traverse. The electrodes space of 5m between each. The levels of those traverses are shown in the satellite image illustrated in figure 10. The survey was completed by using a 41-channel array in winner configuration. In average, 190 data points were collected for each (41-electrode) in one Traverse and about 950 data points in average were collected for total of five traverses in this site. The total length of traverses at this site was 1000 m, covering an area of 30000 m²

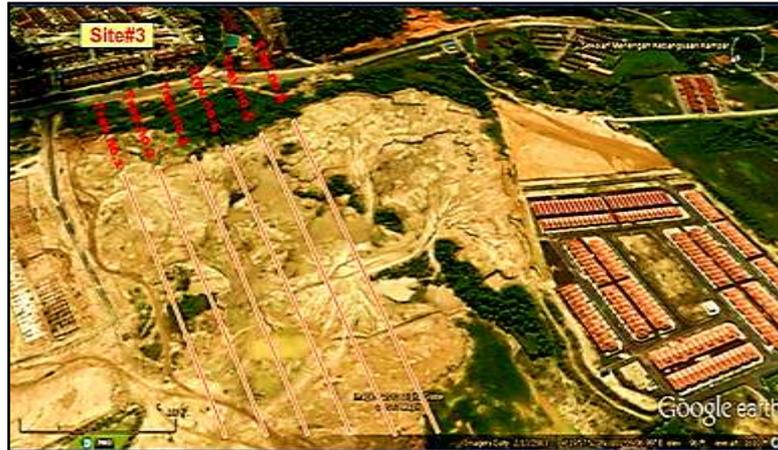
Figure 11: Google satellite image map (2003) viewing the locations of resistivity traverses which controlled in construction site #3 (Kampar-Taman Bandar Baru)

Electrical resistivity tomography (ERT) were applied in six electrical resistivity traverses, traverse no.1 to traverse no.6 were controlled over along the survey area in construction site #3 located in Kampar-Taman Bandar Baru near Tesco Kampar by using 81-channel array in winner configuration. The direction of these traverses in (NE86°SW) and the level of those lines are shown in the satellite image illustrated in Figure 11. The length of each traverse is 400 m and the spaced interval between each traverse is at 25 m and with electrode spacing of 5.0m. About 340 data points were collected for each (81-electrode) in one traverse, and on average about 2040 data were collected for total of six traverses in this site. The total length of total traverses at this site was 2400 m, covering an area of 60000 m².

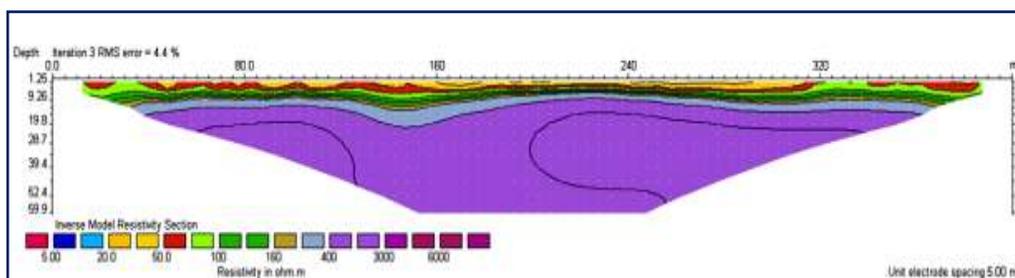
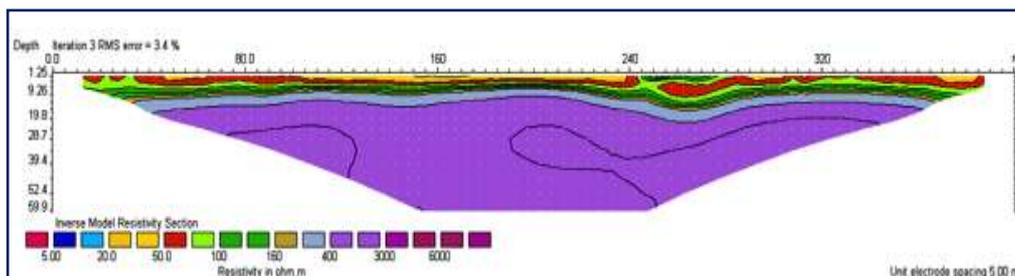
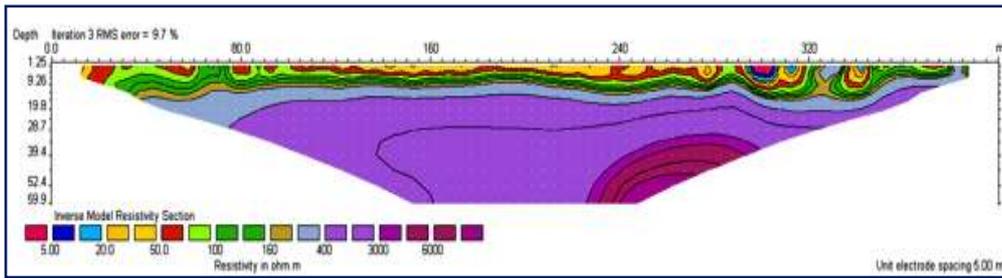
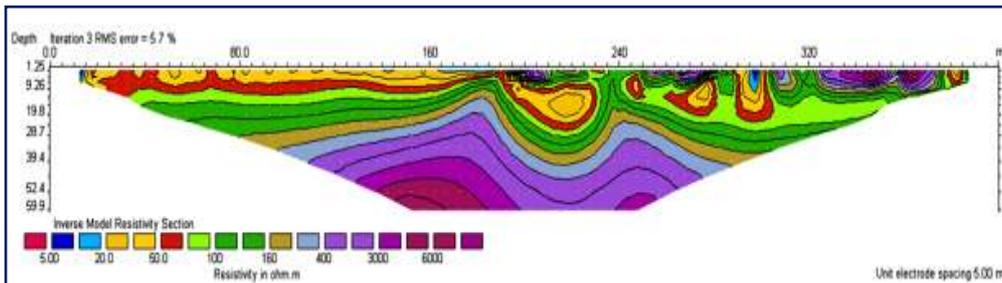
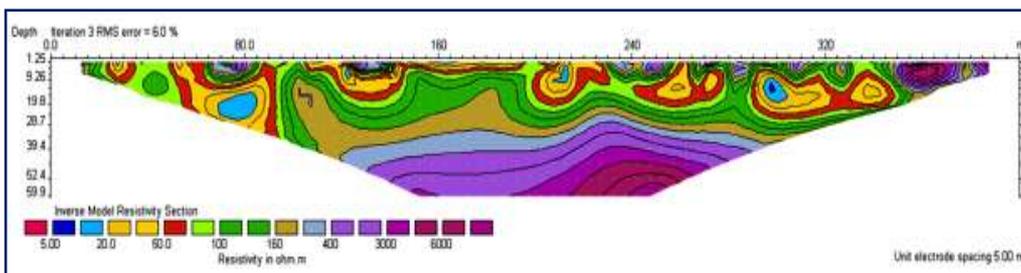
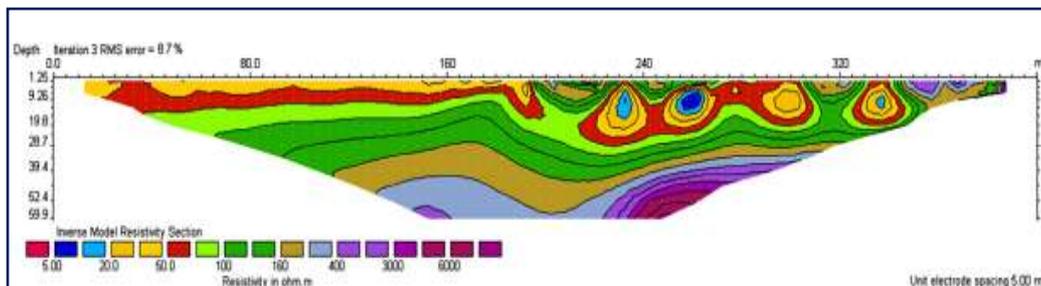
Figure (12 - A) Inverse model of electrical resistivity section for traverse no. 1 (Taman Bandar Baru Putra)

Figure (12- B) Inverse model of electrical resistivity section for traverse no. 2 (Taman Bandar Baru Putra)

Figure (12- C) Inverse model of electrical resistivity section for traverse no. 3 (Taman Bandar Baru Putra)

Figure (12- D) Inverse model of electrical resistivity section for traverse no. 4 (Taman Bandar Baru Putra)

Figure (12 - E) Inverse model of electrical resistivity section for traverse no. 5 (Taman Bandar Baru Putra)

Figure (12 - F) Inverse model of electrical resistivity section for traverse no. 6 (Taman Bandar Baru Putra)

Figure 12(A-F): Inverse model of electrical resistivity section from traverse #1 to traverse #6, viewing the interpreted location of karst features (cavities and sinkholes) in Construction site #1 (Taman Bandar Baru Putra)

The most geo-hazardous area was found in construction site #1(Bandar Baru Putra) extended beneath resistivity traverses no.4. Furthermore, it's extended beneath resistivity traverses no.5. Various types of sinkholes observed and identified. These features are harmful because some are in-filled with water, while others with thick clay and in-filled with sandy or silty clay, which could collapse when subjected to piping under load. Also, lenses with various depth. Some contain thick clay, while others are in-filled with sandy or silty clay.

This site is normally situated over a high topography area above sea level and a flat terrain of marbleized limestone bedrocks. The electrical resistivity data were collected in this construction site and built up in electrical resistivity tomography sections. The interpretations of Tomography or image sections were clarified in the deficiency of borehole control, by utilizing data posited in table 3. The interpretation confirms that a variety of sinkholes that are present in this site, mainly the soil cover collapse type and unmitigated, can clearly be seen between resistivity traverse #3 and traverse #6. The inverse model of electrical resistivity section from traverses no.1 to traverses no.6 in figure 12 (A-F), viewing the interpreted location of shallow karst features (sinkholes and cavities) in Taman Bandar Baru Putra view.

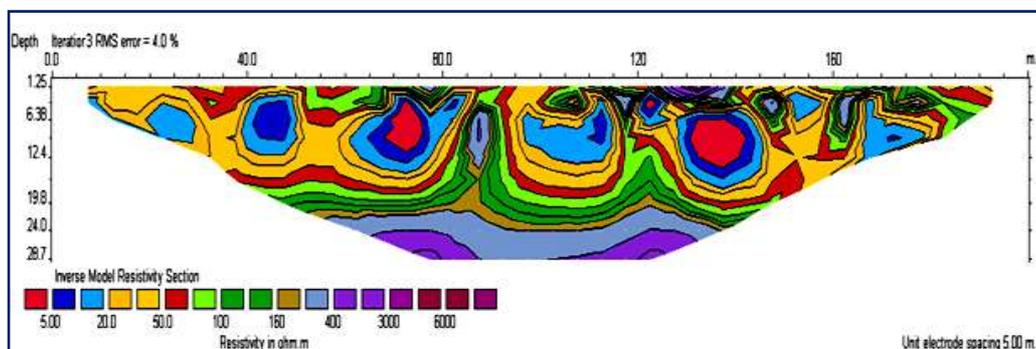
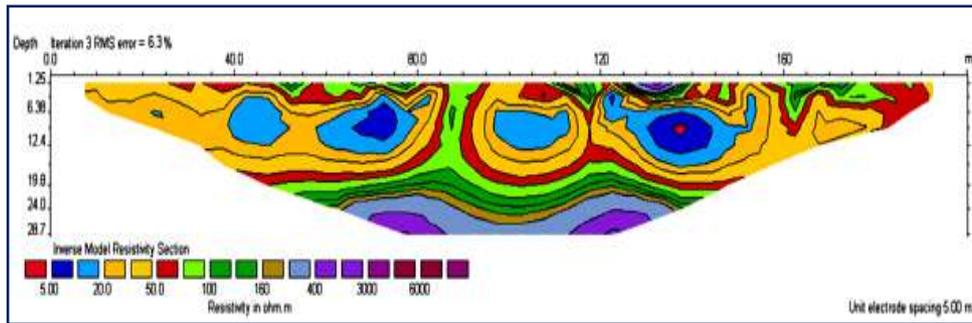
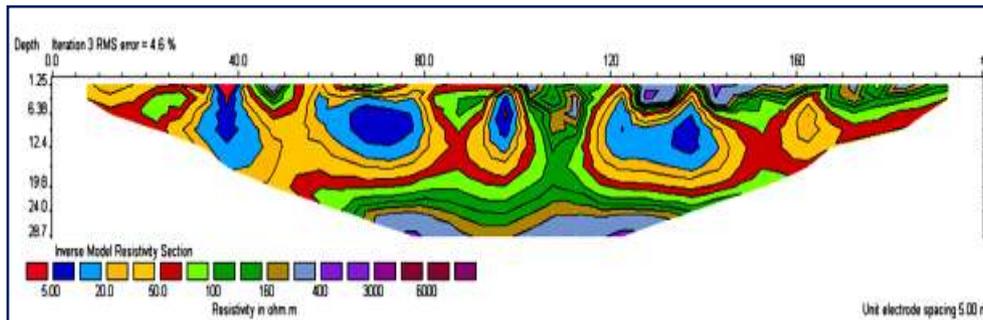
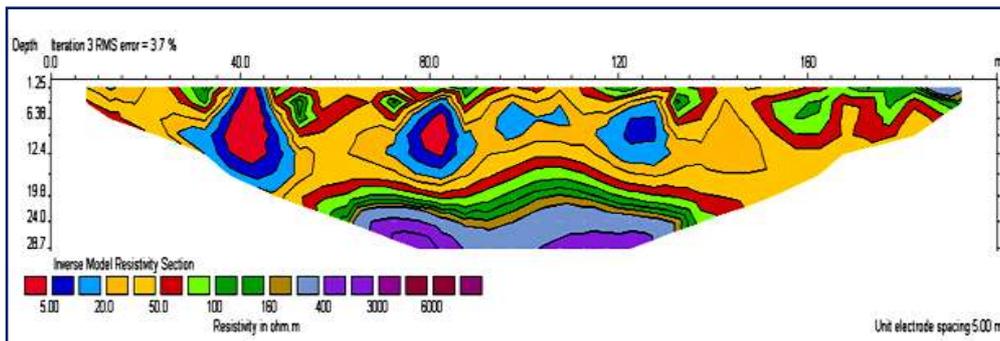
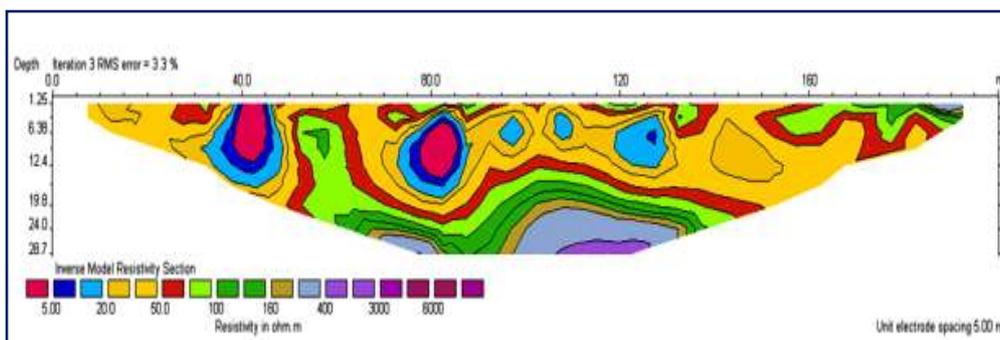
Figure (13 - A) Inverse model of electrical resistivity section for Traverse no.1 (Gunung Rapat view)

Figure (13 - B) Inverse model of electrical resistivity section for Traverse no.2 (Gunung Rapat view)

Figure (13 - C) Inverse model of electrical resistivity section for Traverse no.3 (Gunung Rapat view)

Figure (13- D) Inverse model of electrical resistivity section for Traverse no.4 (Gunung Rapat view)

Figure (13- E) Inverse model of electrical resistivity section for Traverse no.5 (Gunung Rapat view)

The most geo-hazardous area in construction site #2(Taman Gunung Rapat view), were found beneath resistivity traverse no.1. Furthermore it's identified extended beneath resistivity traverse no.2 and in traverse no.3, 4 and traverse no.5 which affected in different places by various types of soil cover collapse sinkholes, soil pipes and lenses. These features are harmful because some were in-filled with water, while others with thick clay or with sandy or silty clay, which could collapse when subjected to piping under load of structures.

The inverse model of electrical resistivity section from traverses no.1to traverses no. 5 in figure 13 (A-E) viewing the interpreted location of shallow karst features (sinkholes and cavities) in Gunung Rapatview

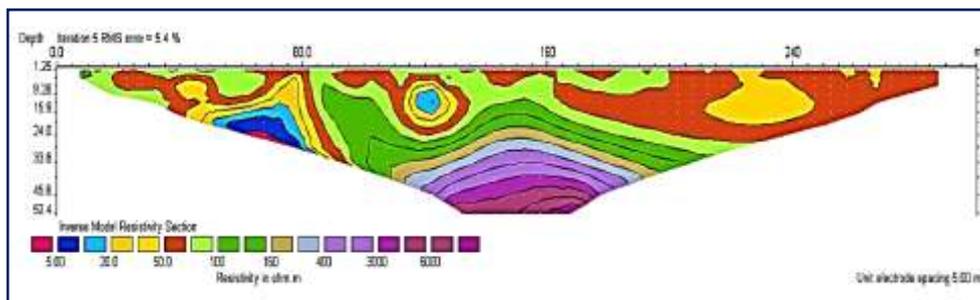
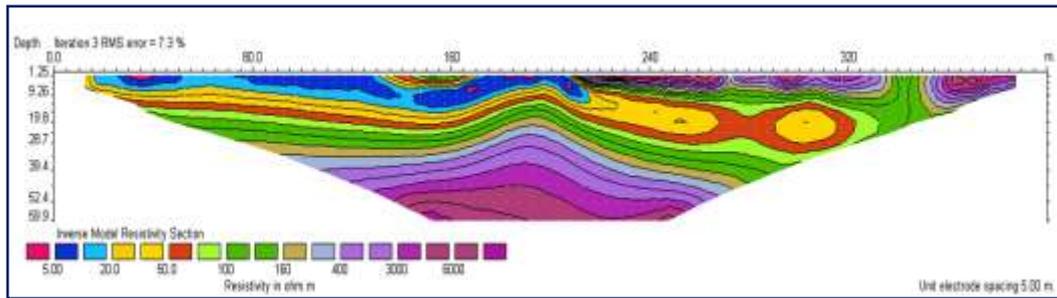
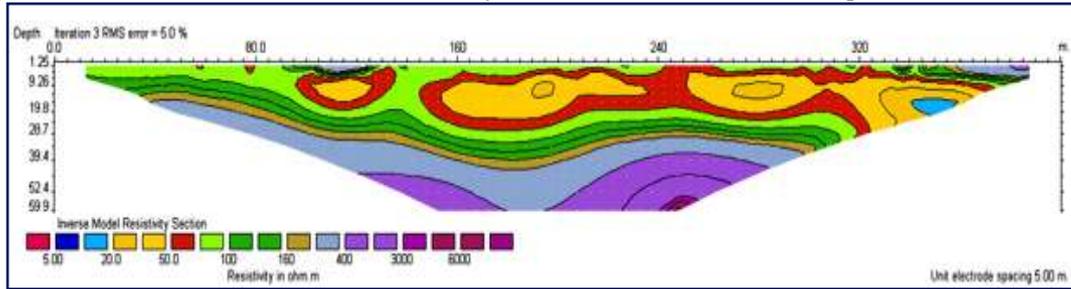
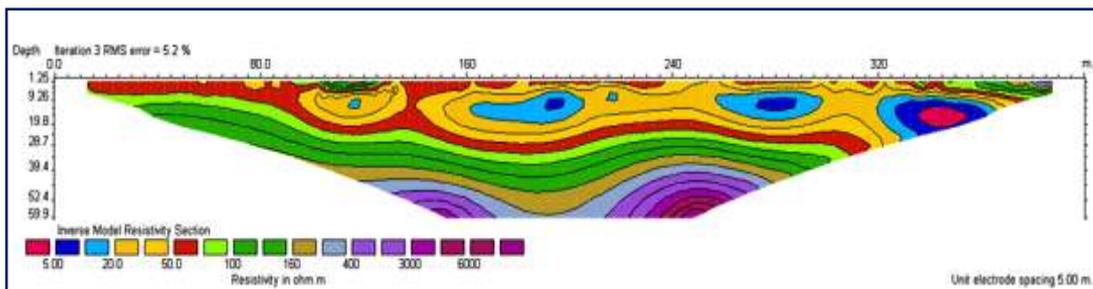
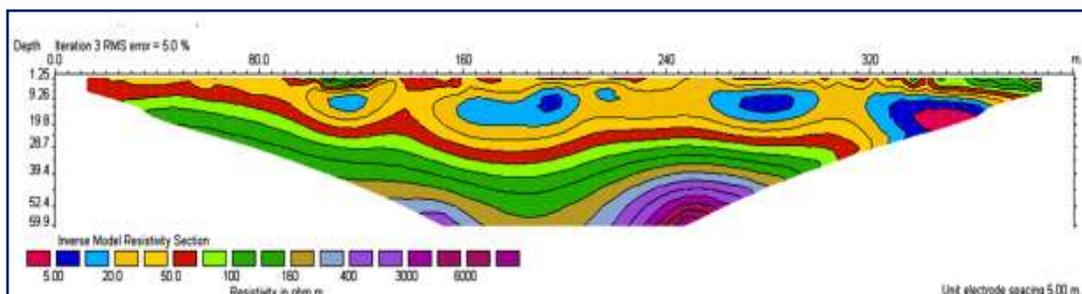
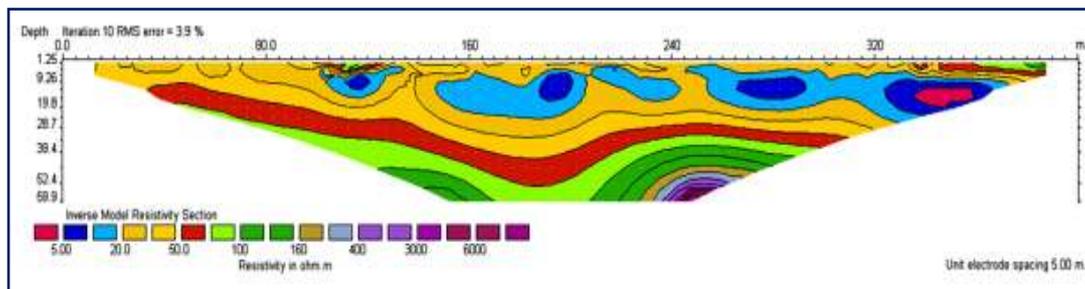
(Figure - A) Inverse model of electrical resistivity section for Traverse no. 1 (Kampar- Taman Bandar Baru)

(Figure - B) Inverse model of electrical resistivity section for Traverse no. 2 (Kampar- Taman Bandar Baru)

(Figure - C) Inverse model of electrical resistivity section for Traverse no. 3 (Kampar- Taman Bandar Baru)

(Figure - D) Inverse model of electrical resistivity section for Traverse no.4 (Kampar- Taman Bandar Baru)

(Figure - E) Inverse model of electrical resistivity section for Traverse no.5 (Kampar- Taman Bandar Baru)

(Figure -F) Inverse model of electrical resistivity section for Traverse no. 6 (Kampar- Taman Bandar Baru)

The most geo-hazardous area in construction site #3(Kampar - Taman Bandar Baru), were found beneath resistivity traverse no.1. Furthermore it's identified extended beneath resistivity traverse no.2, 3, 4, 5 and traverse no.6. This area is hazardous because of the presence of thick layer of stiff and non-stiff clay. Furthermore this layer affected in different places by various types of cover collapse sinkholes, lenses, depressions and channel pipes. These features are harmful because some were in-filled with non-stiff clay highly moisturized, while others with stiff clay silty or sandy. Interpretation of (ERT) inverse geo environment model sections can exposed to civil and geo environmental engineers the degrees of karst level, the reason after the appearance of the karst features and the deference in the appearance of the karst features along these sites. Then, can formulate the classification of these construction sites through applying of the engineering classification of karst ground conditions (Waltham & Fookes, 2005). The karst level in construction sites was classified and found mostly ranging between a youthful karst type KII, mature karst type KIII and complex karst type KIV.

This site is normally situated over a flat terrain of marbleized limestone bedrocks located near huge pit of Tin mine. The electrical resistivity data were collected in this construction site and built up in electrical resistivity tomography sections. The interpretations of Tomography or image sections were clarified in the deficiency of borehole control, by utilizing data posited in table 3. The interpretation confirms that a variety of karst features that are present in this site, mainly the soil cover collapse sinkholes, depressions, surface pools and lenses type and unmitigated, can clearly be seen along all resistivity traverses. The inverse model of electrical resistivity section from traverses no.1to traverses no. 6 in figure 14 (A-F), viewing the interpreted location of shallow karst features (sinkholes and cavities) in 1 (Kampar- Taman Bandar Baru).

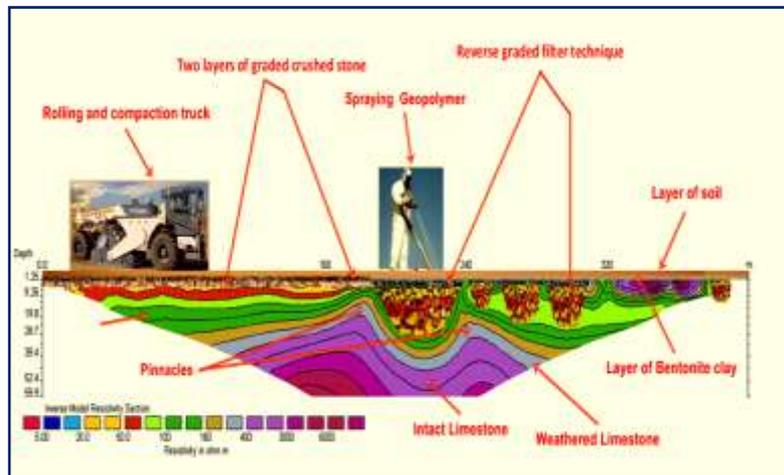
Figure 15: Sinkhole remediation by using the reverse graded filter technique is one of engineering subsurface remediation technique

must be plugged with larger rocks, followed by coarse gravel, then fine gravel, (if possible spray with geopolymer chemical solution to fill the caps between filling material), coarse sand, and finally fine sand. In the third stage, the most upper or a final layer completed with bentonite clay to prevent water seepage from occurring. Then the ground surface will be covered with soil. Surface soil needs improvement in this construction site by rolling and compaction processes to increase the stiffness of the soils. Sinkhole remediation by using the reverse graded filter technique is presented in figure 15.

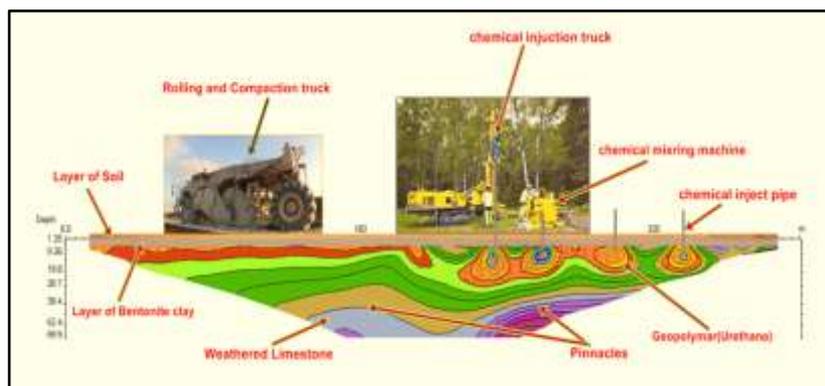
Figure 16: The deep grouting by injecting of chemical solution is one of engineering subsurface remediation technique

Chemical grouting, which is a form of penetration grouting, it's a cost effective professional grouting technique that uses grouts to fill small sinkholes, cavities and voids found in the subsurface unconsolidated material with chemical solutions. The solution grouts that are commonly used include geopolymer (urethanes) these will strengthen the ground and prevent excessive movement. Chemical grout is injected through the joints and gaps in the surrounding soil, where it will solidifies with the soil to appear it's relatively impermeable and hard. The deep grouting by injection of chemical solution is one of engineering subsurface remediation technique as presented in figure 16.

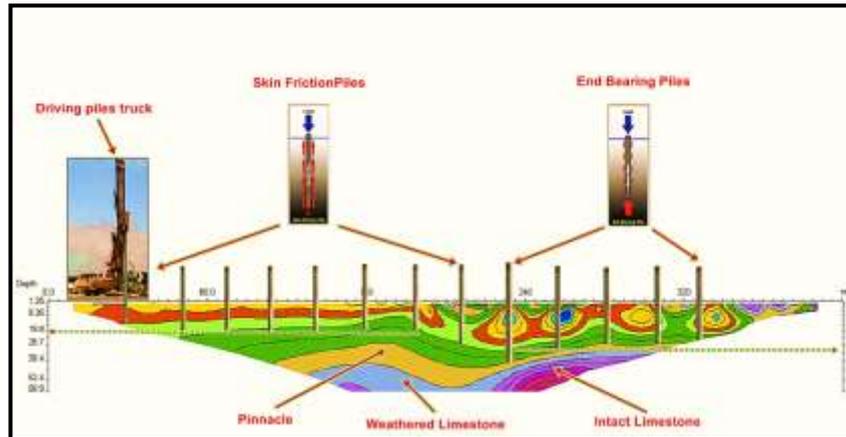
Figure 17: applying long skin friction or end bearing piles will not be economically the ideal solution

When the construction sites have difficult conditions such as, it contains a thick layer of soil and having a low bearing capacity. Choosing long skin friction or end bearing piles will not be economically the ideal solution. Because long piles are need to be driven along at a depth between 19.8m and 28.7m as shown in figure 17.

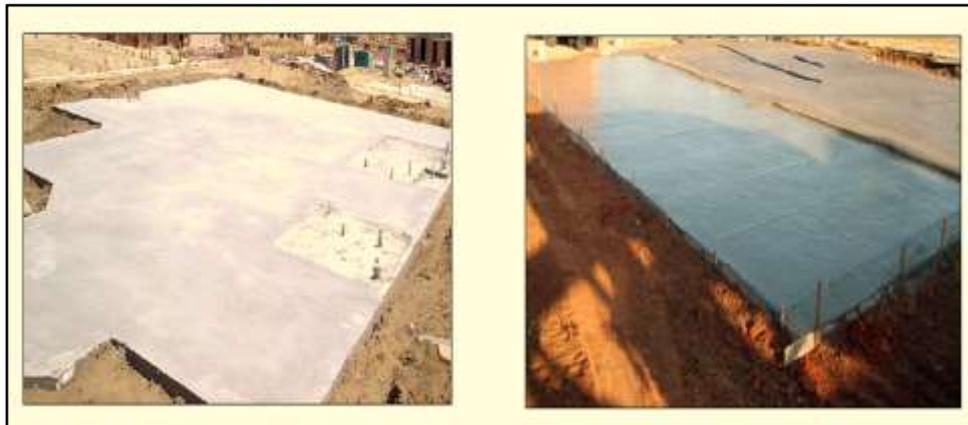
Figure 18: Raft or floating foundations which is convenient in construction site #1

Raft foundations, also known as floating foundations and are made of concrete so that they can float over weaker soils. When the construction site with difficult conditions as the soil having a low bearing capacity, an economical solution raft foundations types can provide support to structural loads. Raft foundation is the economical solution in this site where the deep piles foundations will be used with length more than 29.0m become possible and not economical. When the piles foundation cannot be used constructively an independent column footing becomes unworkable. The type of Raft foundations which is convenient in construction site #1 are presented in figure 18.

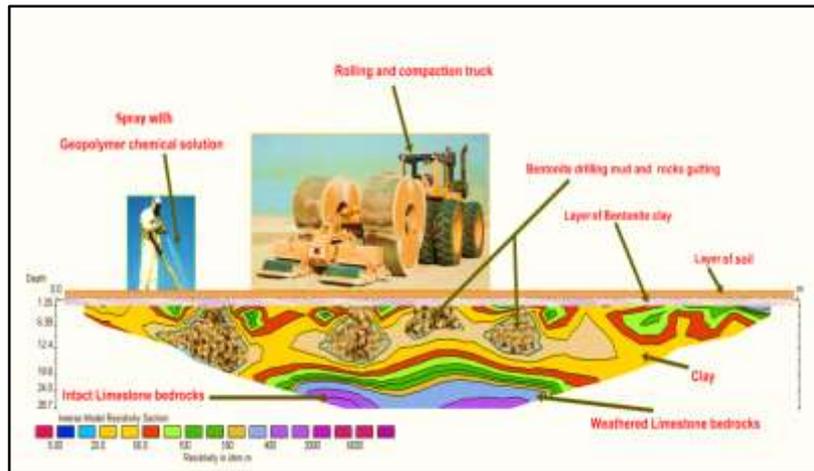
Figure 19: Small sinkholes remediation by using Bentonite drilling mud and the rock cutting from the oil and gas drilling operation

Preparing the land for future development construction project consists of many stages. First stage is cleaning the land from the plants and bushes. Second stage, small sinkholes remediation by using Bentonite drilling mud and the rock cutting from the drilling operation as one of the steps of environmental management in oil and gas exploration, after the water and other liquids are removed to refill the small sinkholes in this construction site would be the ideal solution. To fill these small sinkholes, first excavate the holes, then filling it with bentonite drilling mud and the rock cutting. After that if possible to spray the filling sinkholes with geopolymer chemical solution to fill the gaps between the rocks fragments. The third stage, the upper most of the sinkhole area completed with bentonite clay about 4.0/5.0 inches to prevent water seepage from occurring. After that the final layer of the ground surface will be covered by soil about 6.0/7.0 inches. Surface soil needs improvement in this construction site by rolling and compaction processes to increase the stiffness through decreasing the permeability in this construction site. Small sinkholes remediation by using of Bentonite drilling mud and the rock gutting from the drilling operation presented in Figure 19.

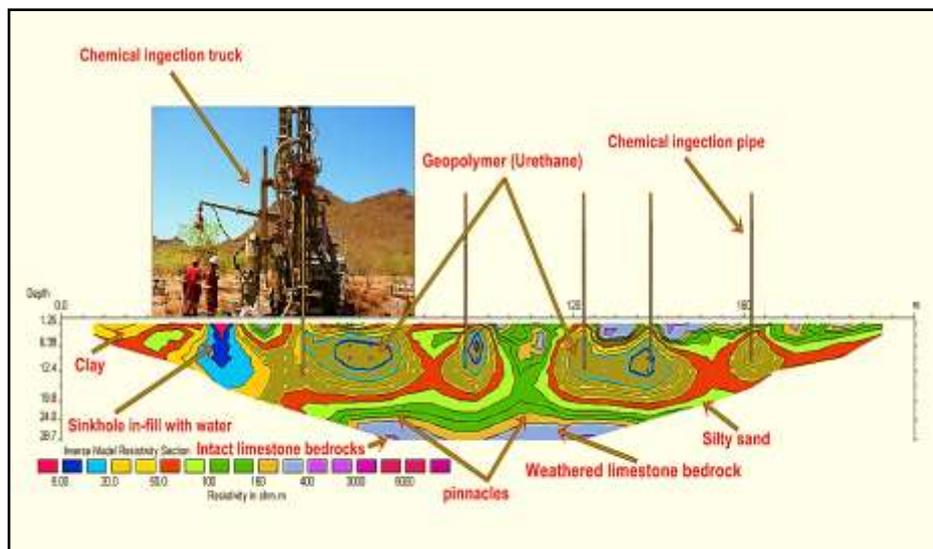
Figure 20: The deep grouting by injection of chemical solution is one of engineering subsurface remediation techniques

Deep grouting by using of geopolymer chemical solution grouts (urethane) is a form of penetration grouting. It is a process that uses chemical solution forms to fill the small sinkholes, cavities, voids and fissures in the soil. The best type of soils suited for this technique are granular soils, with significant fine sand content, that strengthen the ground and prevent excessive movement. Chemical grout is injected through the joints and a gap in the surrounding soil, where it solidifies with the soil making it appear relatively impermeable and hard. The deep grouting by injection of chemical solution is one of engineering subsurface remediation techniques as presented here below in figure 20.

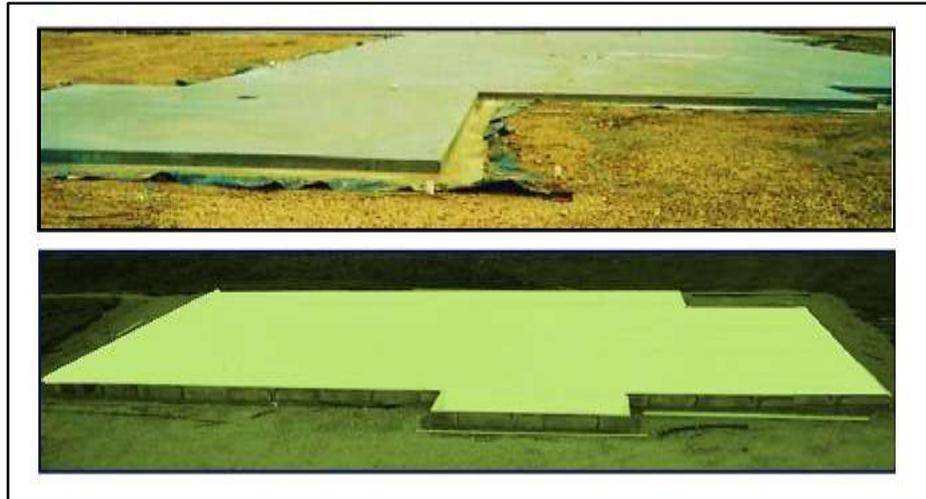
Figure21: Raft foundations or floating foundation which is convenient in construction site #2

Raft foundation (also known as floating foundation) is required and necessary where soils have low bearing capacity and have to hold up heavy structural loads on swampy land, soft clay, and unconsolidated soil material. Raft foundation is necessary where an area that subsidence may occur from different reasons such as, due to the presence of soil cover collapse sinkhole. The changes in the ground water level especially in this area with extended soil. Raft foundation is the economical solution in this site where the deep pile foundations are not possible and not economical. The type of Raft foundations which is convenient in construction site #2 are presented in figure 21.

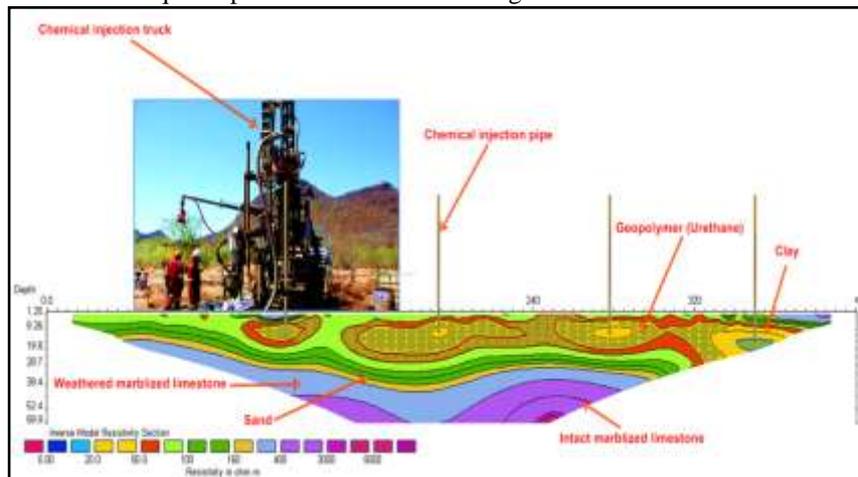
Figure22: Deep grouting by injection of chemical solution is one of engineering subsurface remediation technique

Deep grouting by using of geopolymer chemical solution grouts (urethane) is a form of penetration grouting used to fill the small voids and fissures in the soil. The best type of soils suited for this technique is to strengthen the ground and prevent excessive movement. Chemical grout is injected through the joints and a gap in the surrounding soil, where it solidifies with the soil making itappearsrelatively impermeable and hard and pushes the water from the hole. The deep grouting by injectingchemical solution is one of engineering subsurface remediation technique as presented here below in figure 22.

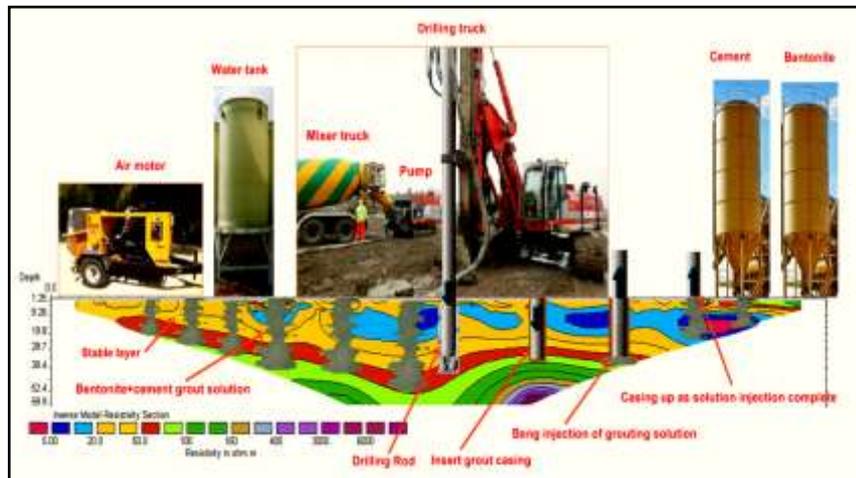
Figure 23: Soil stabilization using Bentonite / Cement grouting technique is one of engineering subsurface remediation technique in construction site # 3

time. The casing is lifted up and pumping recommence grout again at the new level until pumping has reached higher pressures. Then the casing is lifted up more and pumping continues at the subsequently level. The process will create an impenetrable zone and compact the soil /clay or sand around it and increasing the density in the targeted treatment until the area is fully stabilized. As injection points are finished, the grouting process moves on to the next point and continues there. Point by point till all the injection points will completely pumped. Soil stabilization using Bentonite / Cement grouting technique is one of engineering subsurface remediation technique in construction site # 3 as presented in figure 23.
