Review of repair and rehabilitation in RCC buildings

Ms. Smita Sambhaji Patil.
Student at Rajarambapu Institute of Technology, Sangli

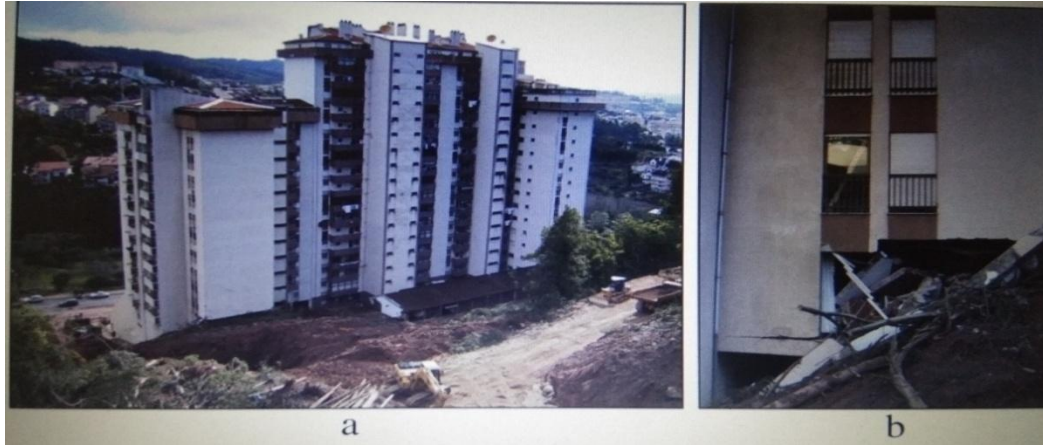
Fig. (a) Rear (West) façade of the building, a few days after the accident.
(b) Detail of the total collapse of the outer columns of the damaged rear body of the building.

The year 2000 was an unusually rainy year. Just three days before the new millennium, at 19:00 h, a substantial landslide occurred, causing severe damage in the RC structure of a 16-story residential building, erected in the beginning of the 1980s in Coimbra, Portugal. The first two levels of three columns were completely destroyed and, as a result, the rear body of the building supported by these, with a dimension in plant of 9.5×6.7 m², became a 7.0 m span cantilever with 12 stories. However, the damage could have been much more severe if the flow of that significant mass of soil and debris had not been damped by part of the 2-story parking garage located on the building's backyard that completely vanished.

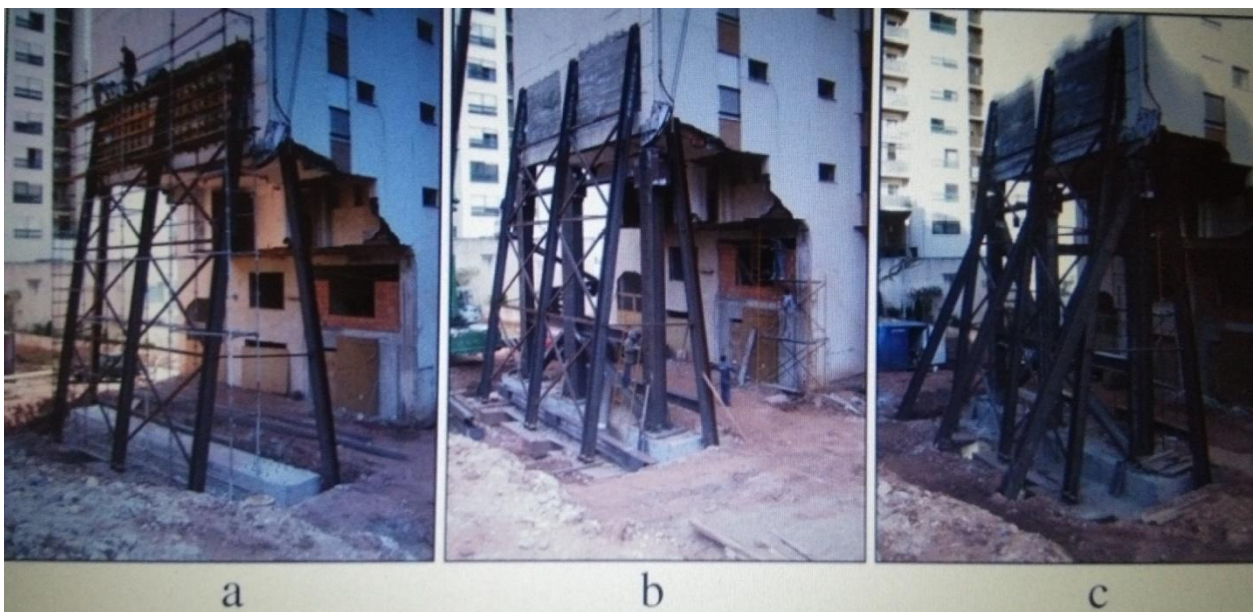
Fig. (a) Foundation for the retrofitting steel frame and shear wall. (b) Assembling the retrofitting steel frame. (c) Additional bracing steel shores

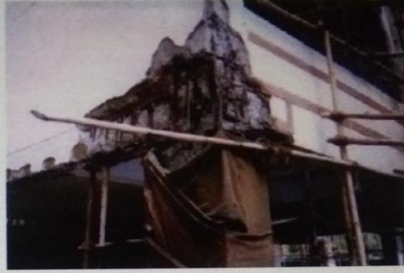
Fig.1 De-lamination of beam concrete cover due to rebar corrosion. **Fig.2-** Severe corrosion and spalling of beam - column junction due to poor workmanship and in-adequate cover at GF level.

Visual inspection of the buildings indicated heavy rebar corrosion as a result of carbonation due to environmental attacks. At certain locations of beams, columns, fins and slabs concrete cover had got spalled (Fig 3) and some shear stirrups were totally eaten up by corrosion (Fig1). Beam - column junctions were badly cracked (Fig 2). Some masonry walls at GF level were totally cracked due to earthquake. A number of columns had continuous vertical cracks along the line of concrete cover thickness (Fig 4). The visual inspection necessitated the need for detailed evaluation for design of the rehabilitation design.

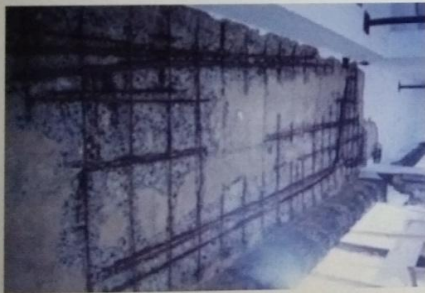
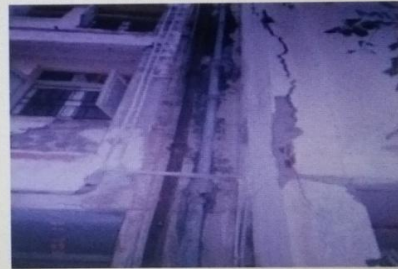
Fig.3 De-lamination of concrete cover due to severe corrosion of rebars of roof slab. **Fig. 4-**Continuous wide crack in column due to corrosion of longitudinal steel at concrete cover depth.

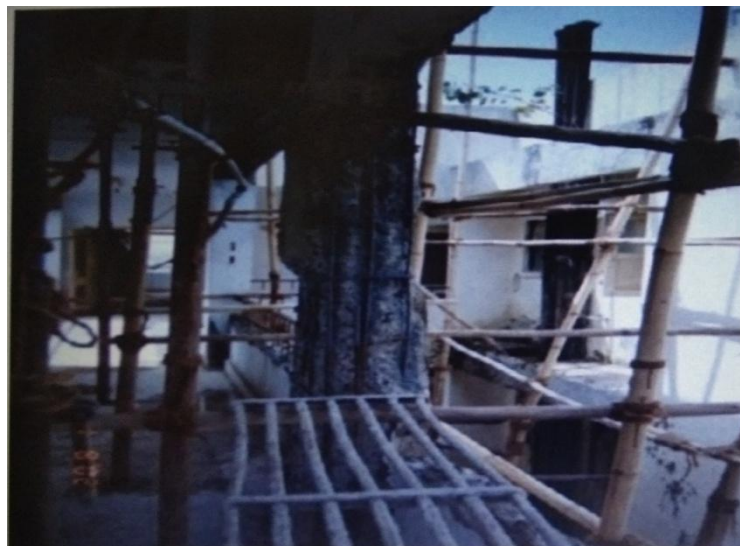
Fig. Column rebars with anti -corrosive coating

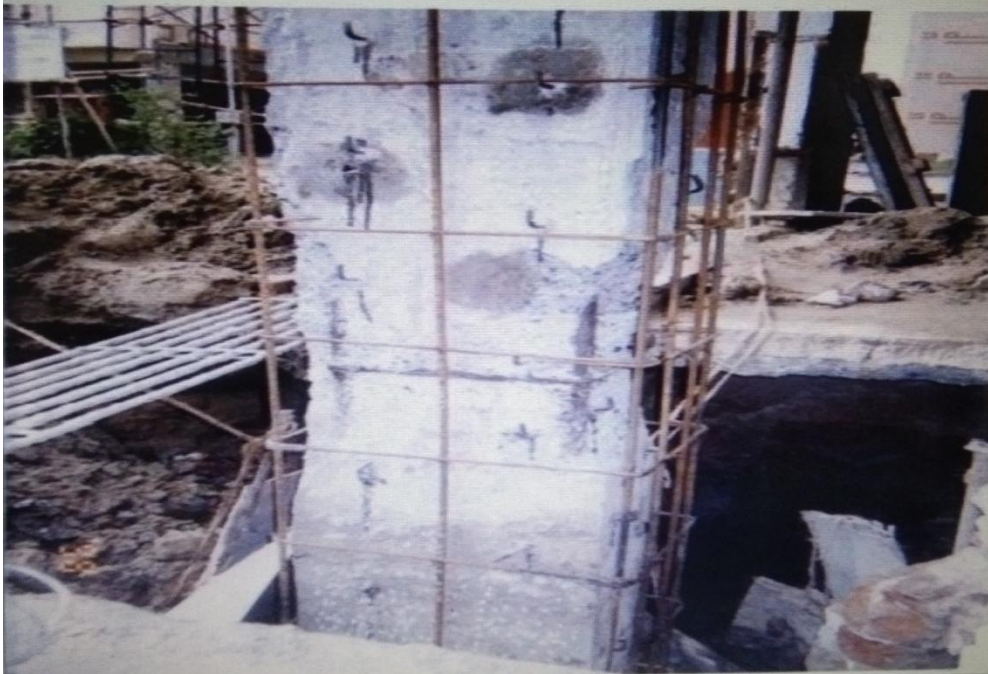
Fig. Jacketing of columns from the footing level.

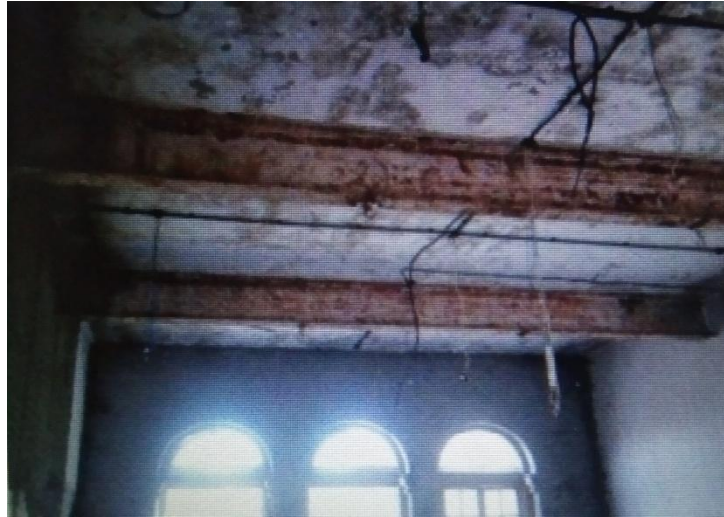
The author identified various problems such as structural cracks in masonry walls, crack in lime concrete slab, collapse of column portion and roof leakages. These are caused due to poor load distribution, poor waterproofing, seepage of water and water logging.

Fig. Roof Leakages

Author suggested several suitable solutions for the above said problems. Epoxy grouting is used for strengthening of weakened and cracked masonry walls. Jacketing of wall surfaces was made by applying mesh nonferrous steel reinforcements and by filling the gaps with lime mortar. Cracks in lime concrete slab were fixed by welding of steel members. Collapse of column portion was restored by removing the collapsed portion and reconstructing the portion was carried out using same type of stone and mortar. Roof leakages were restored by providing proper slopes and by replacing the corroded members using Lead flashing.
