Study of Drastic Disaster Events between 2010-2020 in District Pithoragarh by Using Remote Sensing and GIS Applications

The higher Himalayan region of Uttarakhand as well as district Pithoragarh is an environmentally sensitive area suffering from extreme weather and geodynamical events and hazards such as— rock fall, Land creeping, mud flowing, heavy rain fall, cloudbursts, flash floods, mass wasting, landslides and recurring earthquakes are selected for the present study. The Main Central Thrust passes through the district Pithoragarh which separates the Greater and Lesser Himalayas regions. Munsyari, Bangapani, Dharchula, Tejam, Didihat and Kanalicheena Tehsil of this district were severally affected due to the drastic disaster events from the disaster year 2010 to 2020. This study aims to identify and geo-tagging disaster sites yearly for preparing hazarded site maps to study disasters impact on the district Pithoragarh. A detailed field survey was conducted by using GPS in district Pithoragarh to find out the implications and distribution of different disaster events causing damage to life, livestock and property in the study area. Between 2010 to 2020, there were 174 people d

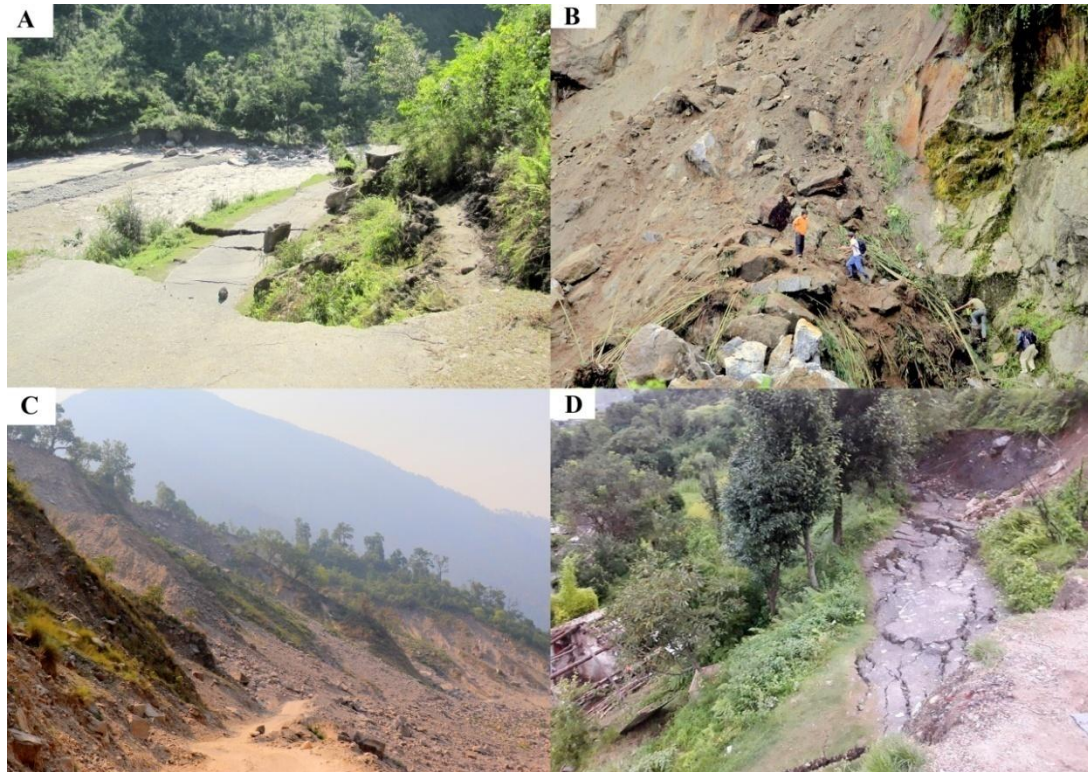
Plate-1: Impact of landslides and land creeping in district Pithoragarh: (A) Madkote to Munsyari motor road affected by land creeping (2013), (B) Tawaghat to Garbyang motor road affected by land slide (2014), (C) Ghigrani is a all-weather landslide zone (2018) and (D) Josha village affected by land creeping (2020) (based on field survey).

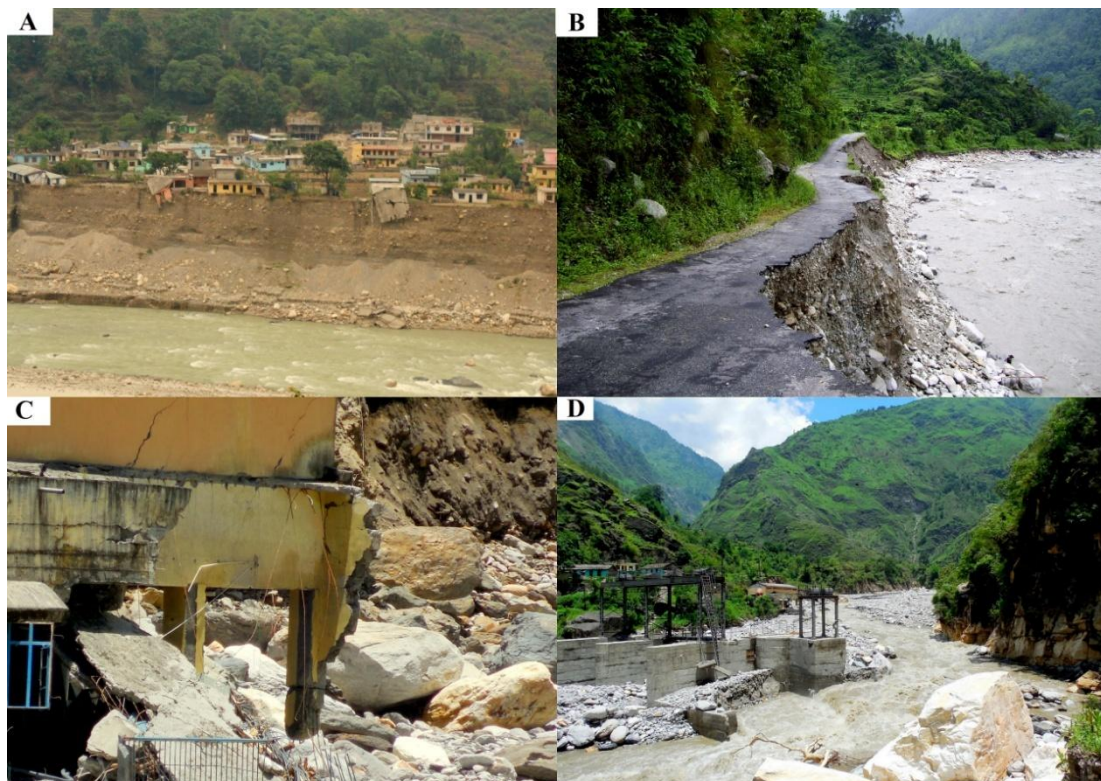
Plate-2: Impact of flash flood and mass wasting disasters in district Pithoragarh: (A) at Ghatta Bagar (2013), (B) at Mori village (2013), (C) at Dani Bagar (2016) and (D) Himalaya Hydro Power Project Dam damaged at Bali Bagar (2018) (based on field survey).

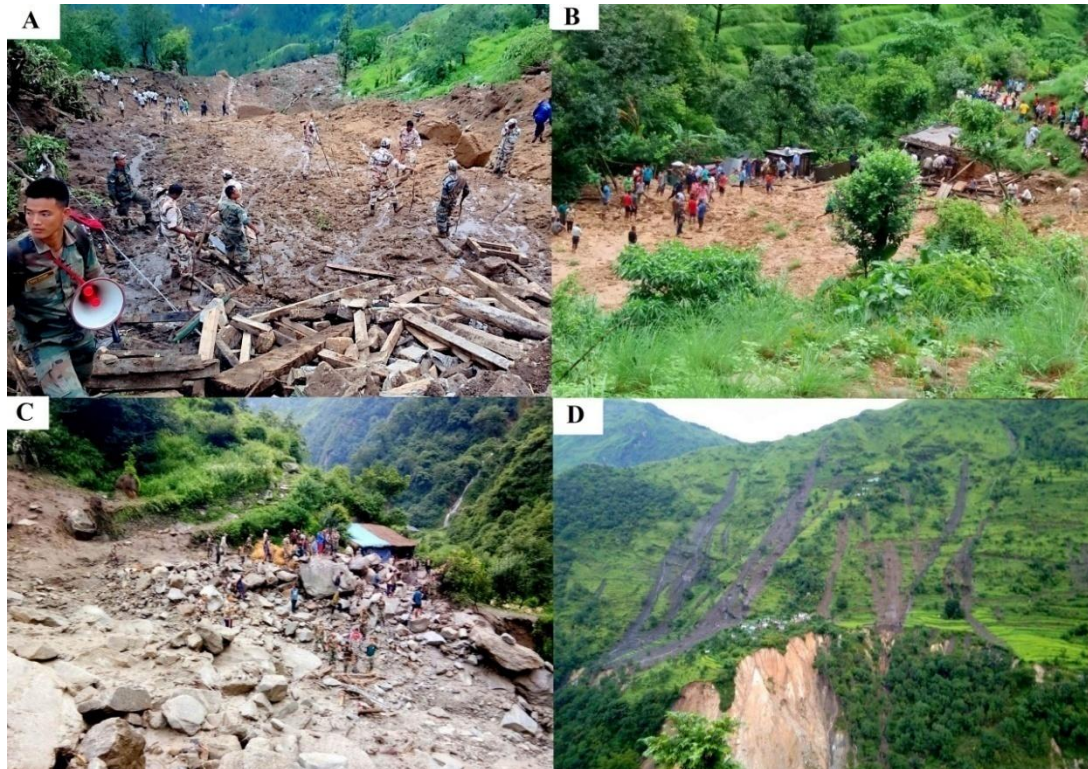
Plate-3: Impact of cloudburst and mud flowing events in district Pithoragarh: (A) at Bastari (2016), (B) at Naulara, Near Nachani (2016), (C) at Malpa (2017) and (D) at Tanga (2020) (based on field survey and DDMO Pithoragarh).

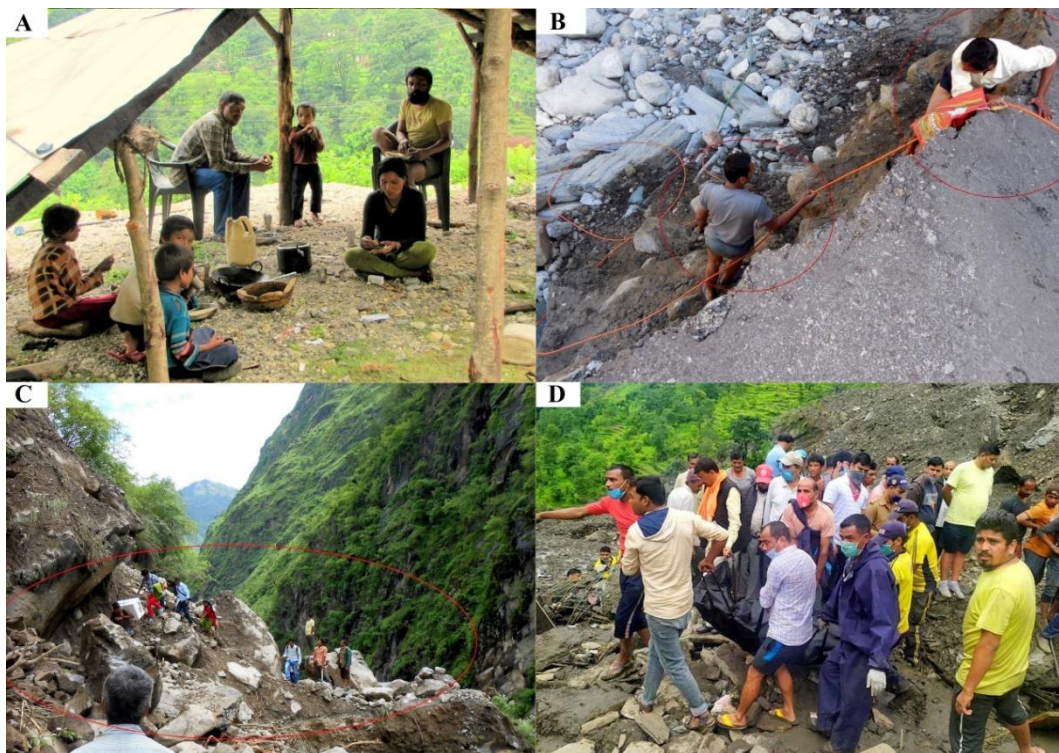
Plate-3: Impact on society by disaster events in district Pithoragarh: (A) Homeless people at Umargada village affected by flash flood (2013), (B) Seraghat to Madkote motor road affected by mass wasting (2013), (C) Tawaghat to Shobla motor road affected by landslide (2017) and (D) Tanga village affected by cloudburst (2020) (based on field survey and DDMO Pithoragarh).
