# **A Case Study on Earthen Embankment Protection Techniques**

Kuttanad is one of the few places in the world where farming is carried out at below sea level. The main crop produced in Kuttanad is paddy. The method employed to avoid water ingress and to maintain soil fertility in the paddy fields involves construction of a bund which makes the soil suitable for cultivation. However, the recent floods in the state has shown us that such bunds are susceptible to damage from flood pressure and this badly affects the livelihood of farmers. This situation calls for a detailed study on bund protection systems currently used and rethinking of the design of the bunds. The study intends to focus on understanding the methods employed by farmers for the protection of their paddy fields below sea level in Kuttanad area of Kerala state with thrust on the issues faced by them due to frequent floods in the region. The heavy floods in the state in 2018 particularly devastated agriculture cultivation due to bund failures in Kuttanad and have prompted the authorities for rethinking upon the existing bund protection systems. This paper intends to highlight the issues with existing bunds using second

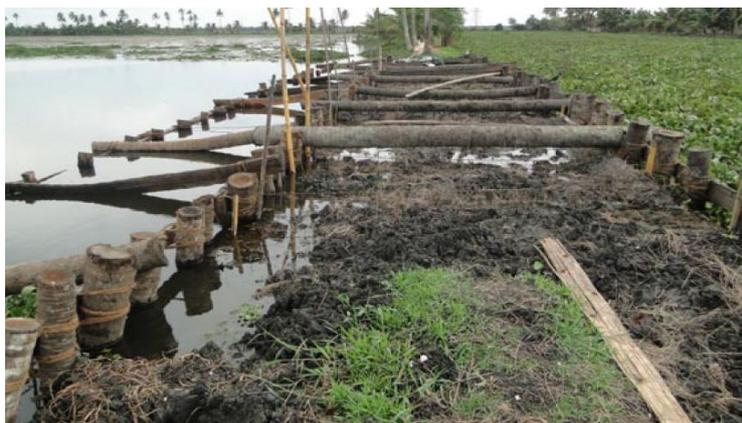
Figure 4. Bund Construction in Kuttanad

Typical bund construction techniques which are adopted conventionally in the past is as follows: The process of reclamation of land for cultivation would start with identification of the shallow regions in the vast stretches of Vembanad Lake. Mark the boundaries by erecting bamboo poles, which are subsequently protected with construction of strong bunds around the boundaries. The bund construction and maintenance are highly skilful tasks, for which an array of long and stout coconut poles would be hammered deep enough into the lake bed in two rows, normally in 1.5 m to 2.5 m width enveloping the entire area and fenced with bamboo (both yellow and green ones) mats on either side. The side walls would be then protected with frames made from aracanut poles and covered with woven coconut leaf plates. The channels of the bund would be filled to the desired height, first with sand, followed by twigs, sedges like Typha and Sheoneplectus (Korapullu) and dead materials usually brought from distant places. These would be interspersed with high quality clay that dug from 20-25 m deep bottom lakes. Clay digging which is also called Kattakuth, would involves diving 20-25 m deep into the Kayal-bed, a task which needs high physical strength, skill, experience and ingenuity for the persons engaged. On an average, 400 to 500 men are engaged in a year to complete the reclamation process of land about 2000 ha size.

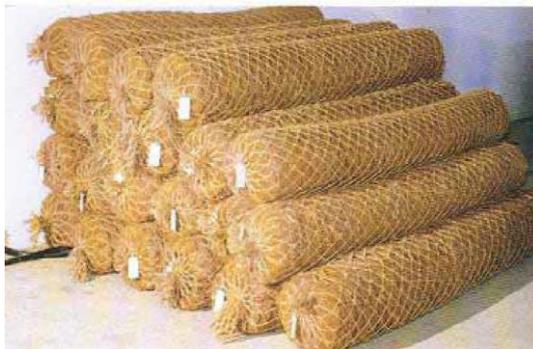
Figure 5. Cocologs used for Bund Construction

Another geo-textile recently introduced for bund protection is the cocolog. Cocologs are made from coir fibre bunches under pressed condition in tubular enclosures of knotted coir yarn. Cocologs are mainly used for protection of vulnerable streams, rivers or lake banks. They are similar to a wooden log in shape. They are available in various diameters, length and weight. The diameter usually varies from 30 cm to 50 cm, weight from 60 kg to 180 kg and the most common used length is 6 metre. Charcoal is also used intermittently for filling the logs as additional manure for faster growth of plants. The rolls are attached at the edges of the bank and secured by wooden stakes/ pegs. The pegs may be used on alternate sides of the log. For high embankment areas with variable water level, several Cocolog can be applied as a stack.
