# Research on flexural performance of composite steel truss without upper chord

CHEN Rongzheng<sup>1</sup>, CAO Kaiqiang<sup>2</sup>

## Abstract

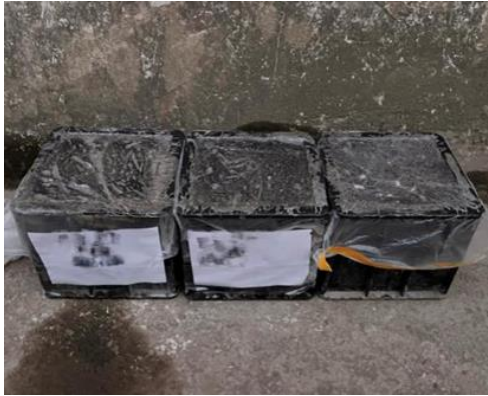
Figure 2.2 Production of standard specimen

The grouting material used in the concrete of this sample has many advantages such as artiveness, self-densification, early high strength, micro-expansion, durability and environmental protection. The pouring is simple and the pouring quality is guaranteed. The concrete material property test adopts standard mold making and curing for 28 days under the same conditions as the specimen. The cube compressive strength test was carried out according to the standard test method provided by GB/T50448-2015, Technical Specifications for the Application of cement-based grouting Materials, as shown in FIG. 2.2 and FIG. 2.3. The test results are shown in Table 2.3.

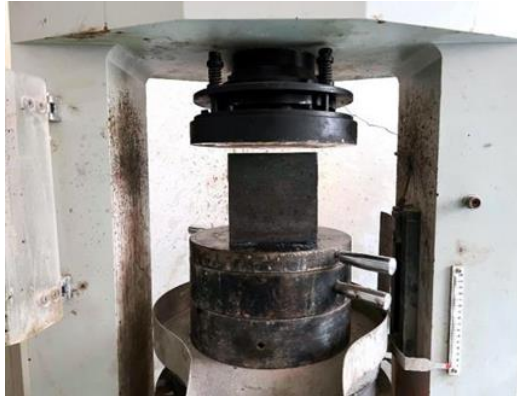
FIG. 2.3 Compressive strength test of concrete

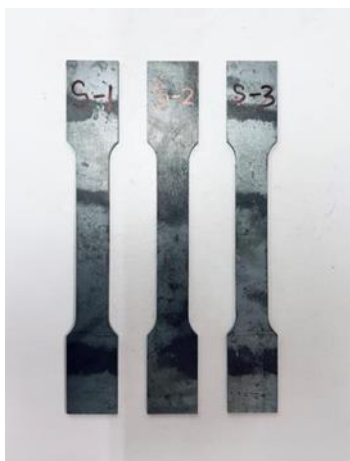
Figure 2.5 Steel proportion sample

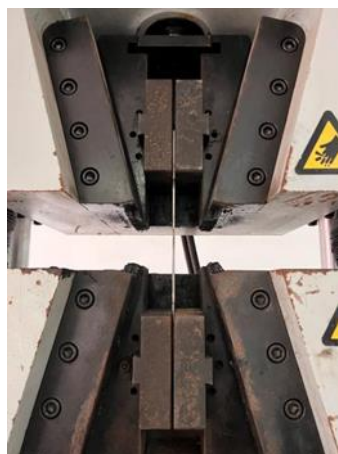
Figure 2.6 Steel properties test

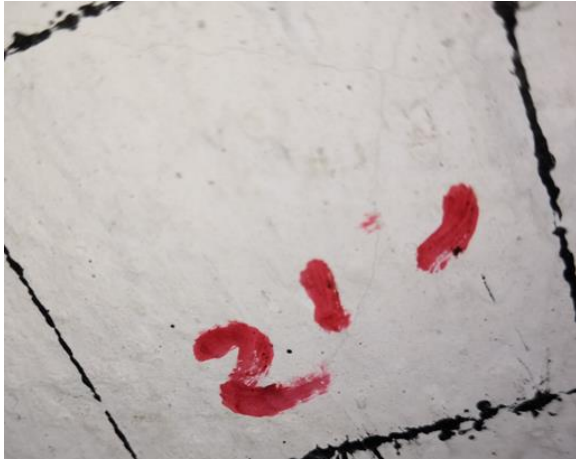
Figure 2.14 Crack No. 2 (Grade 7)

**Elastic stage:** In the early stage of loading, the specimen showed a large stiffness, and the relationship between the overall deflection of the specimen and the load was linear. In the process of load grade from the first load (5kN) to the sixth load (30kN), the overall stiffness of the specimen did not decrease, and the concrete slab did not crack. When the load grade reaches the seventh grade (34.7kN), cracks No. 1-8 appear near the loading point on the bottom of the concrete slab, but the cracks are too small in width and short in length (no more than 100mm), as shown in FIG. 2.14 and FIG. 2.15. Different from the area near the left and right equinox, there is no obvious crack in the middle span area of the concrete slab, as shown in Figure 2.16.

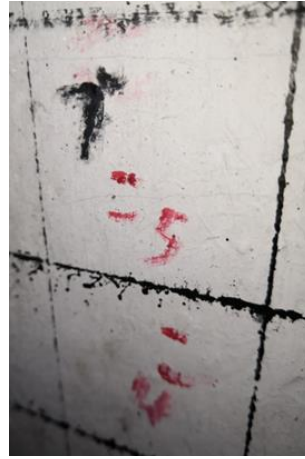
Figure 2.15 Cracks No. 4, 5 and 7 (Grade 7)

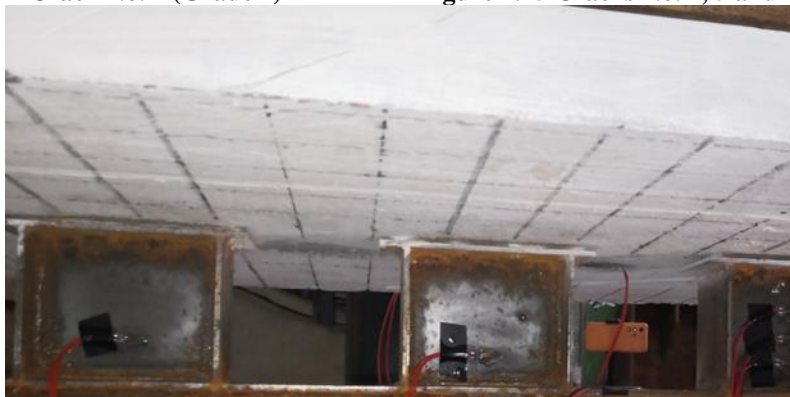
Figure 2.16 Mid-span concrete slab bottom (Grade 7)

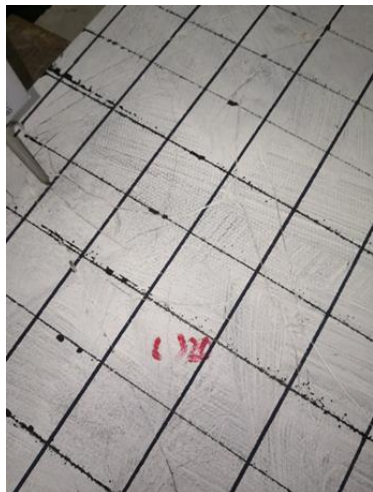
Figure 2.17 Crack on the top of the concrete slab at the left end (Grade 9)

**Elastoplastic stage:** After loading grade 8 (39.9kN), cracks 9-11 were added to the bottom of the concrete slab near the left loading point, and cracks also appeared in the remaining areas. In addition, when the load reaches 40kN, the stiffness of the specimen decreases, and the specimen begins to enter the stage of elastic-plastic development. After loading to the ninth level load (44.7kN), cracks appear on the top of the concrete slab at the fixed hinge support, as shown in Figure 2.17. The cracks that originally appeared also developed rapidly, such as crack No. 4, which developed to the middle of the bottom of the concrete slab, as shown in Figure 2.18. When the load grade reaches grade 10, many cracks develop to the side of the slab, as shown in Figure 2.33. Cracks also appear on the top of the concrete slab on the right side (crack No. 25), as shown in Figure 2.19, some cracks run through to the other side (with the chord as the axis), and the mid-span deflection is 24.1mm. After entering the nonlinear development stage, the deflection increases rapidly and the cracks at the bottom of the plate develop rapidly. After the load value is loaded to 49.5kN, this phenomenon is more obvious. After the jack loading, the load value is not stable and decreases to a certain extent. Therefore, after the tenth grade load, the test adopts displacement control loading. It is worth noting that in the elastoplastic stage, when the load grade reaches 12 (57.4kN), the concrete slab bottom between the No.2 and No. 3 belly rods is stripped, as shown in FIG. 2.20. At this time, it is observed through the signal acquisition system that the steel lower chord rod in the mid-span section has entered the yield state in all sections. However, the lower chord web enters the yield state earlier than the lower flange of the lower chord in the right curved shear section. After reaching the load of 13 degrees (59.8kN), the cracks in the bottom of the concrete slab are densely distributed in the pure bending section and the bending shear section, but the cracks in the left bending shear section are significantly more than those on the right.

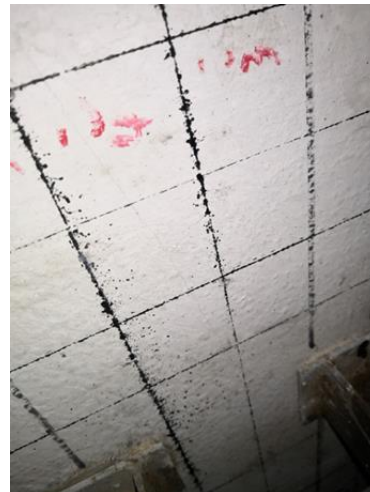
Figure 2.18 Fracture 4 developing to the middle (Grade 9)

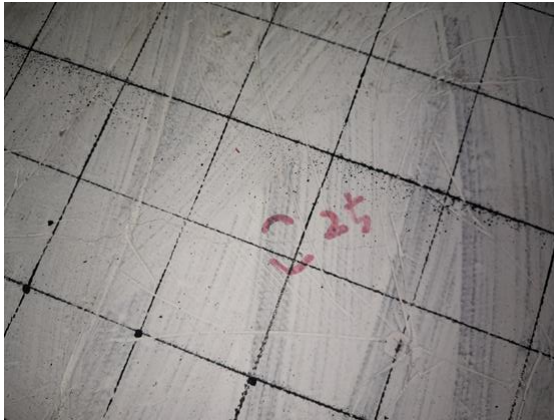
**Figure 2.19 Top crack of concrete slab at right end (Grade 10)**

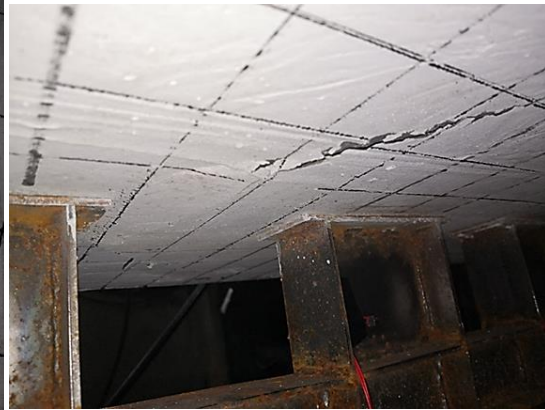
**FIG. 2.20 Peeling of concrete slab bottom**

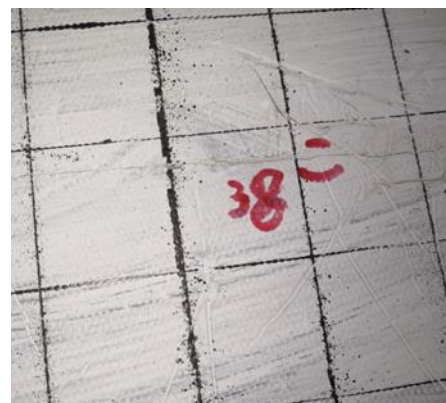
**Figure 2.22 Longitudinal cracks on top of concrete slab (Grade 15)**

Failure stage: After loading to grade 15 load, the overall deformation of the specimen has been serious. As shown in FIG. 2.21, the bending and shearing section of the lower chord has a torsional deformation at the connection between the abdominal rod and the chord rod, and the overall deformation of the specimen presents a "trapezoid" shape. Cracks along the beam length appeared at the top of the concrete slab at the right end, as shown in FIG. 2.22. Cracks developed rapidly at the bottom of the concrete slab at the lower part of the loading point on the left side. The width of the No. 26 main crack expanded continuously, and the neutral axis of the mid-span section was raised to the middle axis of the concrete slab, so many cracks developed to the upper side of the neutral axis. Therefore, it is considered that the specimen begins to enter the failure stage at this time. In the failure stage, the instability of the loading value of the jack is more serious, and the load value will fall back after each loading. In the process of loading from grade 15 to Grade 16 (64.9kN), there is a continuous sound. After the loading, it is found that the splicing place on the right chord of the left No. 3 belly rod is cracked and the fracture is even. At the same time, the bottom of the concrete slab on the right side also showed peeling phenomenon, and the left side was seriously peeling, and there was peeling between the No. 3 and No. 4 belly rods. The cracks became wider and some cracks, such as No. 26 cracks, ran through the bottom of the slab. At this time, the mid-span deflection reaches 81.38mm, reaching 1/34 of the span. In the process of loading to 17 load levels, the chord fracture expanded rapidly. In view of safety considerations, the loading was stopped, and the specimen was considered to have been damaged. At this time, the load value was 64.6kN, and after a period of time the load dropped to 62.8kN. At this time, the specimen was seriously damaged, the deflection increased to 94.13mm, the longitudinal crack through the top of the plate appeared, the crack width of the bottom of the plate increased to 0.66mm, for example, the crack of No. 26 increased to 0.66mm, the peel of the concrete slab became more serious, the opening at the chord fracture expanded to 2.5mm, and the weld was torn. The development of grade 16 to 17 specimens is shown in Figure 2.23-2.30.

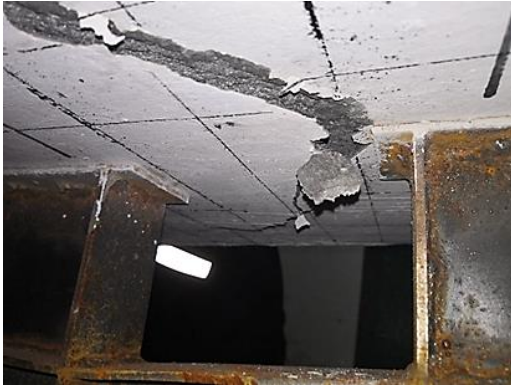
Figure 2.23 Peeling of concrete (Grade 16)

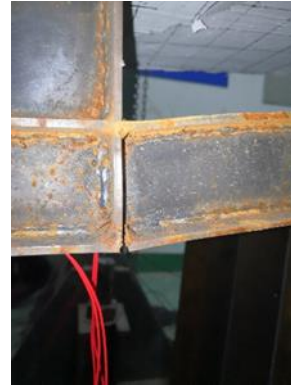
Figure 2.24 Chord fracture (side view)

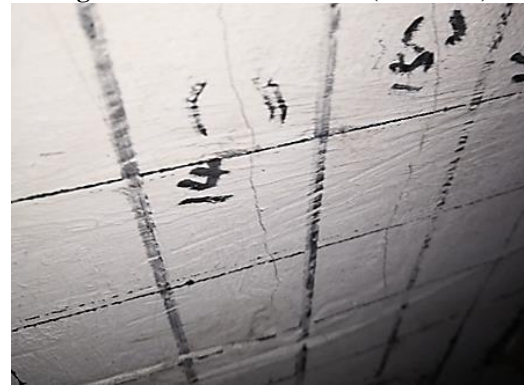
Figure 2.26 Fracture development (Grade 16)

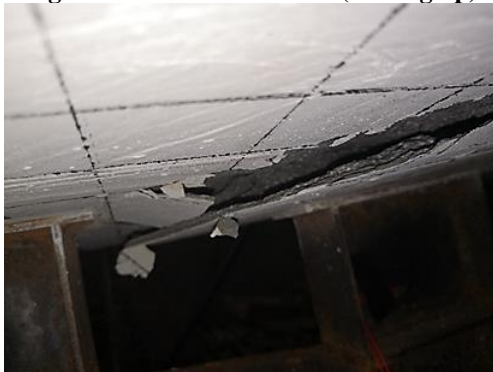
FIG. 2.27 Serious peeling of concrete slab bottom (Grade 17)

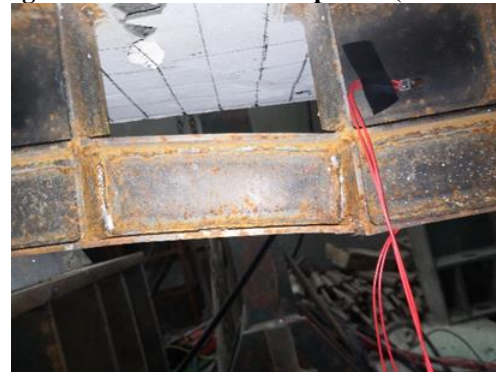
FIG. 2.28 Expansion and severe deformation of chord fracture (Grade 17)

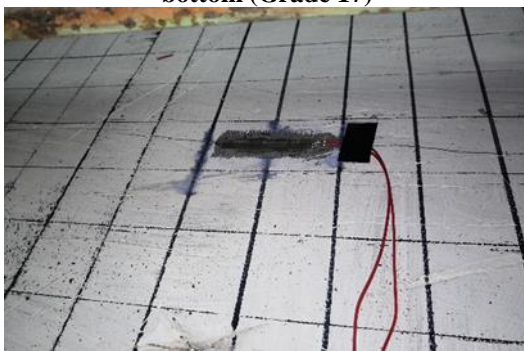
Figure 2.29 Longitudinal penetration of cracks in the top of concrete slab

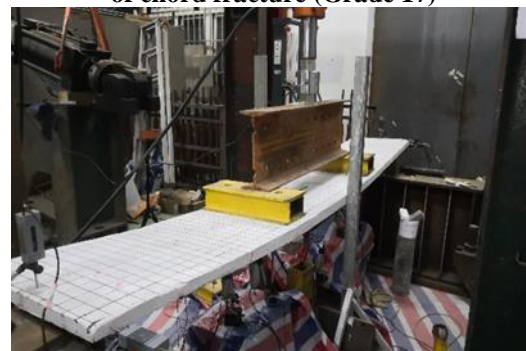
FIG. 2.30 Overall deformation of specimen (grade 17)

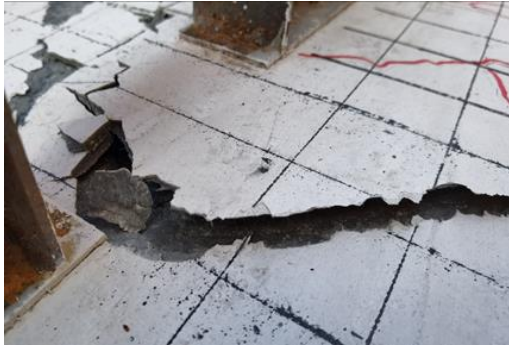
Figure 2.30 Peeling place of the left bending shear section of the bottom of the concrete slab (inverted)

Unloading stage: After loading to grade 17 load, due to the serious damage of the specimen, the specimen is no longer loaded, and unloading is selected to end the test. The deflection of the specimen has a certain amount of retraction in the unloading stage, but the overall residual deflection still reaches 75.1mm. It is worth noting that the interface slip between the concrete slab and the steel beam was not observed during the

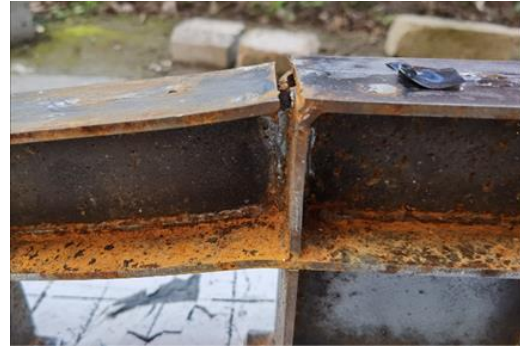
Figure 2.31 Fracture of the lower chord (inverted)

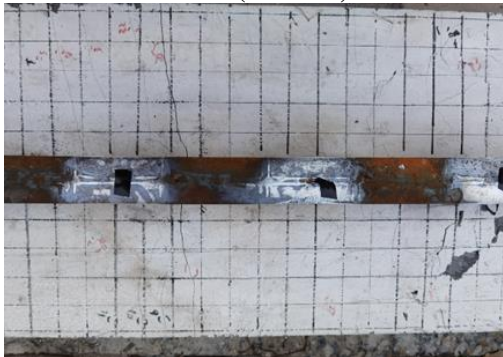
Figure 2.32 Main crack No. 26 (inverted)

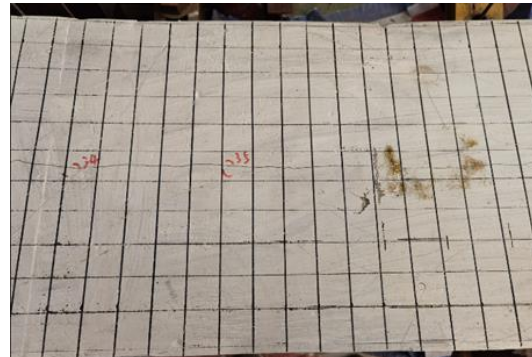
FIG. 2.33 Cracks in the top of the plate along the long direction of the beam

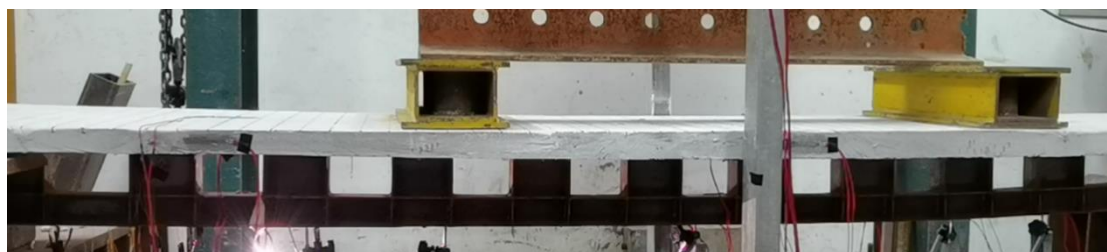
Figure 3.2 Elastic stage

Damage stage: In the process of loading the test load grade from 16 to 17, the deflection of SJ1 rapidly increased from 81.4mm to 94.13mm, while the load decreased from 64.9kN to 64.6kN. During this period, the bottom of the concrete slab appeared serious peeling phenomenon, the chord fracture expanded, the crack at the bottom of the slab developed to the top of the concrete slab, and the concrete slab withdrew from work. Stop loading for safety reasons. The real deflections of the specimen at the three stages are shown in Figure 3.2-3.4.

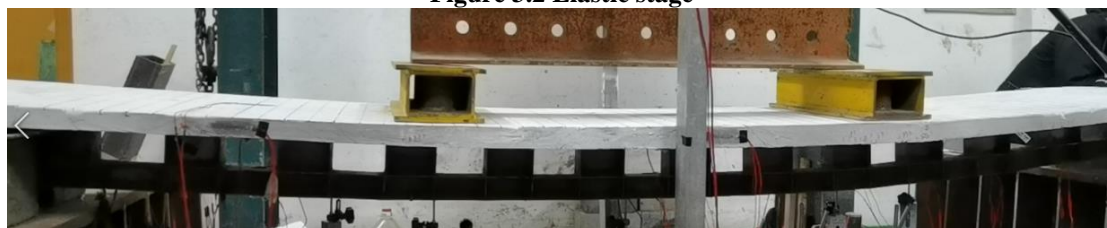
Figure 3.3 Elastoplastic stage

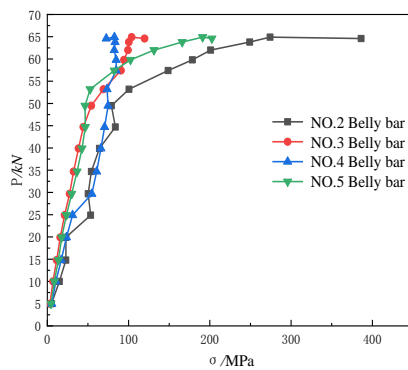
FIG. 3.6 shows the load-stress diagram of the measuring point at the bottom of the belly bar of the left curved shear section. It can be seen from the load-stress diagram that the belly bar of the left curved shear section does not enter the yield stage in the span direction before the 16th load. FIG. 3.7 shows the load-stress diagram of the lower flange measuring points of the lower chord of the above four belly rods. Compared with the load grade of the measuring points at different positions when they enter the yield stage, it can be seen that the closer to the loading point, the earlier the yield time of the lower flange. The lower flange of measuring point No. 5 exceeds the ultimate strength of steel 496.3MPa after the tenth grade load, and enters the strengthening stage. The curve recurred after grade 17 load, which was caused by the fracture of the right chord of measuring point No. 3, which resulted in the redistribution of stress inside the steel truss.

FIG. 3.6 Load-stress relationship of the belly bar in left flexural shear section

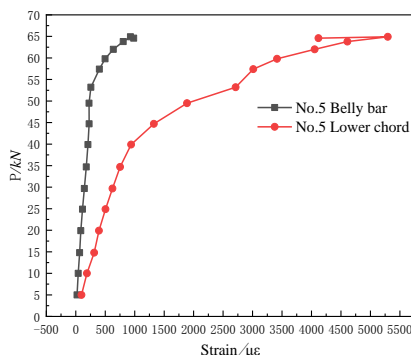
FIG. 3.8 and FIG. 3.9 respectively compare the load-strain relationship between the lower measuring point of the No. 2 and No. 5 belly bar and the lower flange of the lower chord bar in the same section. By observing the two figures, it can be found that the strain generated at the lower part of the belly bar in the same section is much lower than the strain at the lower flange of the chord bar in the same section. FIG. 3.10 shows the strain comparison between No. 6 belly bar in the pure bend section and that in the flexural shear section at the same height measurement point. It can be found that the strain at the bottom of No. 6 belly bar on the right side of the left tripoint is negative, indicating that compressive strain is generated there, which is completely different from the strain stress distribution of the belly bar in the flexural shear section.

FIG. 3.9 Strain of No. 5 belly rod and flange under the same section

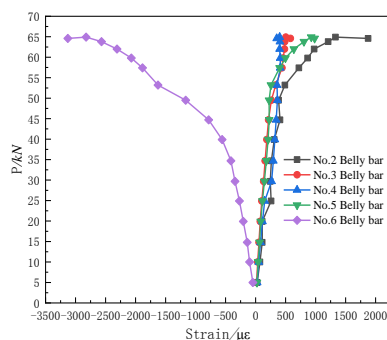
FIG. 3.10 Comparison of load-strain relationship between the abdomen bar of pure bending section and the left bending shear section

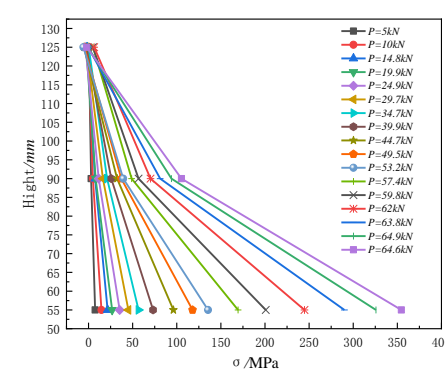
FIG. 3.16 Stress distribution of No. 8 belly bar

FIG. 3.15 shows the distribution of stress in the mid-span section of the chord and the stress in the right flexural shear section along the height under the nine-order load. At this time, the lower flange of the mid-span chord has entered the tension yield state, but the web and upper flange still maintain elasticity, while the whole section of the right flexural shear section is in the elastic stage. The tension stress of the web in mid-span section is less than that of the upper and lower flange, indicating that the upper and lower flange of H-beam chord is the main tension position. Figure 3.16 shows the stress distribution of No. 8 belly bar along the height. According to the analysis of the figure, it can be seen that the belly bar of the pure bending section is in an elastic state during most stages of the whole test, and contributes little to the overall flexural bearing capacity of the composite truss, and its main function is to connect the concrete slab to the chord bar.

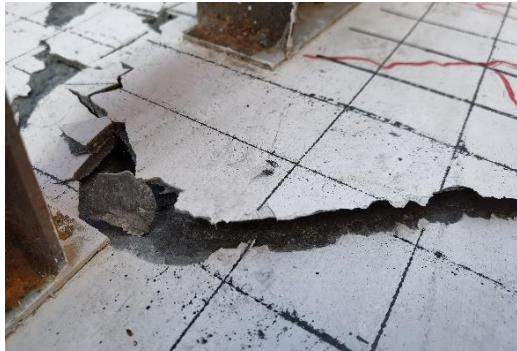
**Fig. 3.20** Peeling of concrete slab bottom

The bearing capacity of this specimen reached the highest value at the 16th load. At this time, the lower flange of the right side of the No. 3 belly bar in the left flexural shear section of the composite floor chord rod broke, and the concrete peel occurred in the left and right flexural shear section of the bottom of the concrete slab, and the left side was more serious. During the loading process of level 16 to 17, the deflection increased rapidly and the fracture of the original chord continued to expand until the composite floor experienced a "bang" sound before the loading stopped. At this time, the composite floor was seriously damaged, cracks appeared on the top of the concrete slab along the long direction of the beam nearly throughout the whole span, and the bottom of the concrete slab was seriously peeled off (FIG. 3.20). A peel joint with a width of 10-15mm appeared, and the chord also showed a large deformation. The crack at the fracture expanded to 2.5mm (FIG. 3.21), and the load dropped to 62.6kN after stopping the loading. Therefore, it was considered that the specimen had reached the state of failure.

top of the concrete plate under the pad has a crack along the beam length at 1/2 of the width of the plate. When failure occurs, the cracks under the left and right loading points are connected along the long direction of the beam, forming cracks that almost run through the whole span.

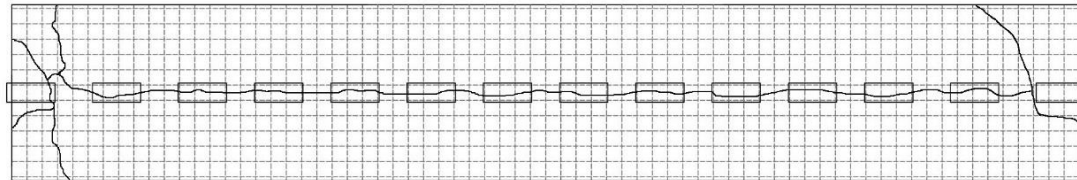
FIG. 2.72 and 2.73 show the crack distribution of the top and bottom of the specimen after loading. It can be seen that the cracks at both ends of the top of the plate are distributed near the No. 1 and No. 14 belly rods, and the longitudinal penetrating cracks basically develop along the steel truss area. The cracks in the pure bend section are relatively fine and mostly surface cracks, which reflects excellent bending resistance. The main crack appears near the left loading point, which develops deeper and wider in the direction of plate thickness, which is one of the reasons for the failure of composite floor. The cracks in the left flexural shear section are closely related to the peeling phenomenon of the bottom of the concrete slab in this area. It can be seen that the main peeling cracks are located in the fastening range between the belly bar and the joint area between the belly bar and the concrete slab, indicating that the shear connection between the belly bar and the concrete slab is reliable, and this intermittent shear connection is also one of the reasons for the peeling of the bottom of the concrete slab.

**Figure 3.22** Crack distribution on top of concrete slab
