## **Improved Automobile Engine Shaft Thrust Pump Cessation Detection**

*Automobile thrust shaft bearing is the most vital module of water pump based on its fatigue cessational consequences that causes the abnormal operation of the system. Conversely, the cessational mechanisms of the bearing are still unclear. In this article, the cessational analysis on the engine thrust shaft bearing was carried out by using the measurement of material composition and properties, observation of macro and micro morphologies, and theoretical analysis of the cessation. The wear behavior and cessational mechanisms were elucidated, and the prevention measures were further proposed. The cessation was identified from the fracture of the bearing cage causing severe wear of the roller and the mandrel originated from the surface fatigue and the cessational attributes to the great radial deflection on load. Additionally, the decreased weight of the impeller and the shaft connector and the increased bearing thickness were recommended to improve the bearing operation.*

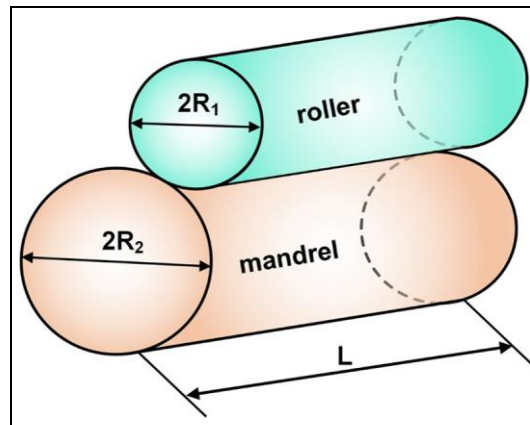
Figure 10. Schematic Diagram of the Paralleled Contact between Roller and Mandrel.

Experimentally discussed above, the roller and mandrel were considered as two elastic cylinders with curved radius of  $R_1$  and  $R_2$ , and lied in contact with parallel axes, as shown in Figure 10. The maximum pressure ( $P_0$ ) could be expressed by Equations 1, 2 and 3 from Hertzian theory (Hertz, 1882)

During operation, the large radial force of the pulley at the dynamic end increased the bearing deflection, and the uncompleted contact decreased the length, further leading to the increased contact force. The abnormal local stress promoted the abnormal operation and serious burning, finally resulting in the fracture of bearing the cage, serious wear of the roller and the mandrel as well as the generations of vibration and abnormal noise.

The radial load of pump shaft bearing mainly consisted of tension of driving belt and the weights of water pump impeller and shaft connector. Hence, the following recommendations and measures are proposed: reducing the weight of water pump impeller and shaft connector, increasing the bearing thickness to improve the radial bearing capacity. The bearing thickness represented the mandrel diameter. As the thickness increased, the mandrel diameter ( $R$ ) in Equation (1) increased, resulting in the decreased contact force. On the other hand, the increased mandrel diameter promoted the reduced the bending deformation of the mandrel and prevented the reduction of length.
